# RotorSport UK Ltd Service Bulletin

<b>Title: Pre-rotator clutch/brake</b>		
<b>SB No.: 076 Iss1</b>	<b>Related documents</b> MC No: MC-260 CCAR No.: CCAR-048	<b>Compliance Category:</b> <b>OPTIONAL</b> <del>or</del> <b>RECOMMENDED</b> or <b>MANDATORY</b>
<b>Applicability</b>		
<b>Aircraft type &amp; model:</b>  Cavalon	<b>Aircraft serial Nos. affected:</b>  All prior to RSUK/CVLN/009

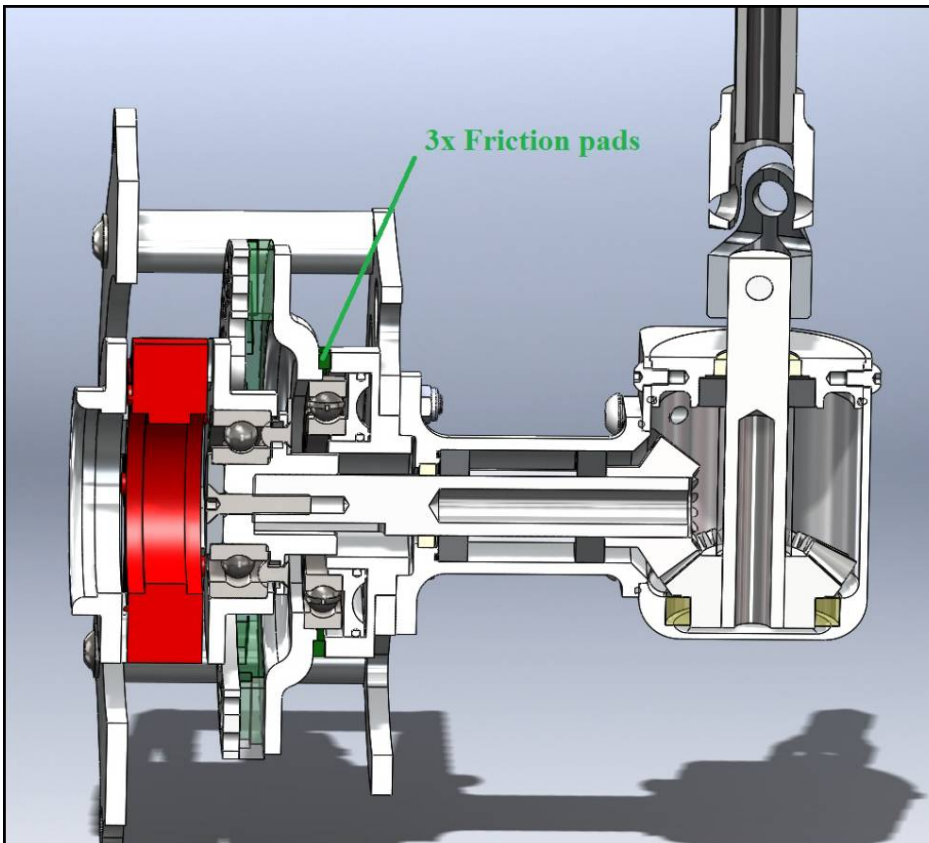
The pneumatically operated pre-rotator clutch of Cavalon aircraft contains sealed-ball-bearings and there have been a few instances of bearing-drag resulting in the drive shafts rotating in flight. By means of three friction pads bonded to the rear of the moving friction-plate it is positively braked when in the clutch-released condition. This service bulletin SB-076 describes how to change the friction plate, or the entire pre-rotator clutch/gearbox assembly (at the discretion of the engineer)

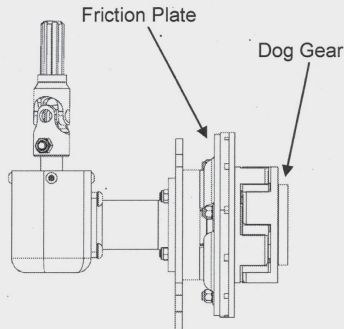
Fig. 1 - Pneumatic Clutch III

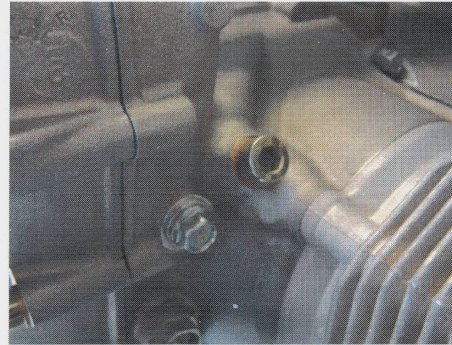
Fig. 2 - M8x20 screw plug

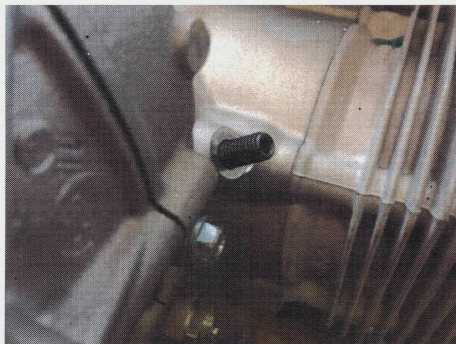
Fig. 3 - Thread Pin M8x50

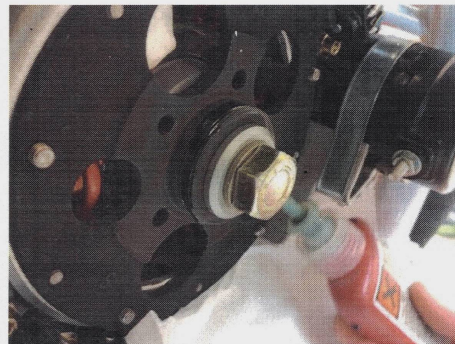
Fig. 4 - Loctite 648 on inner and outer thread

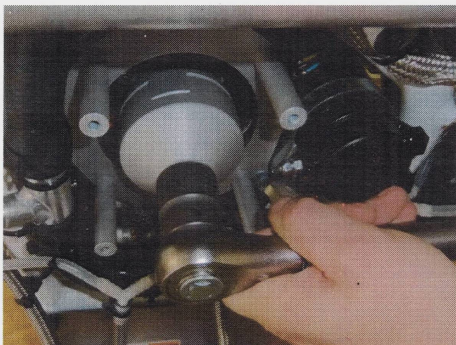
Fig. 5 - Torque dog gear with 140 Nm

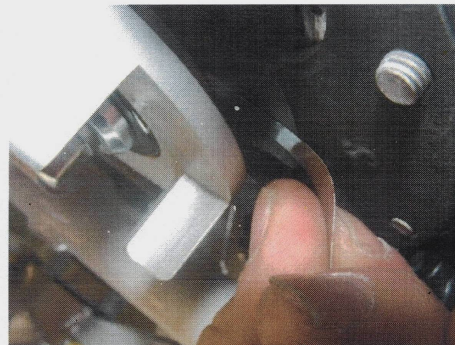
Fig. 6 - Correct mounting position
