# RotorSport UK Ltd

## Service Repair Request and Evaluation/Approval

Repair No.: 009 issue 1

Aircraft type: MTOsport

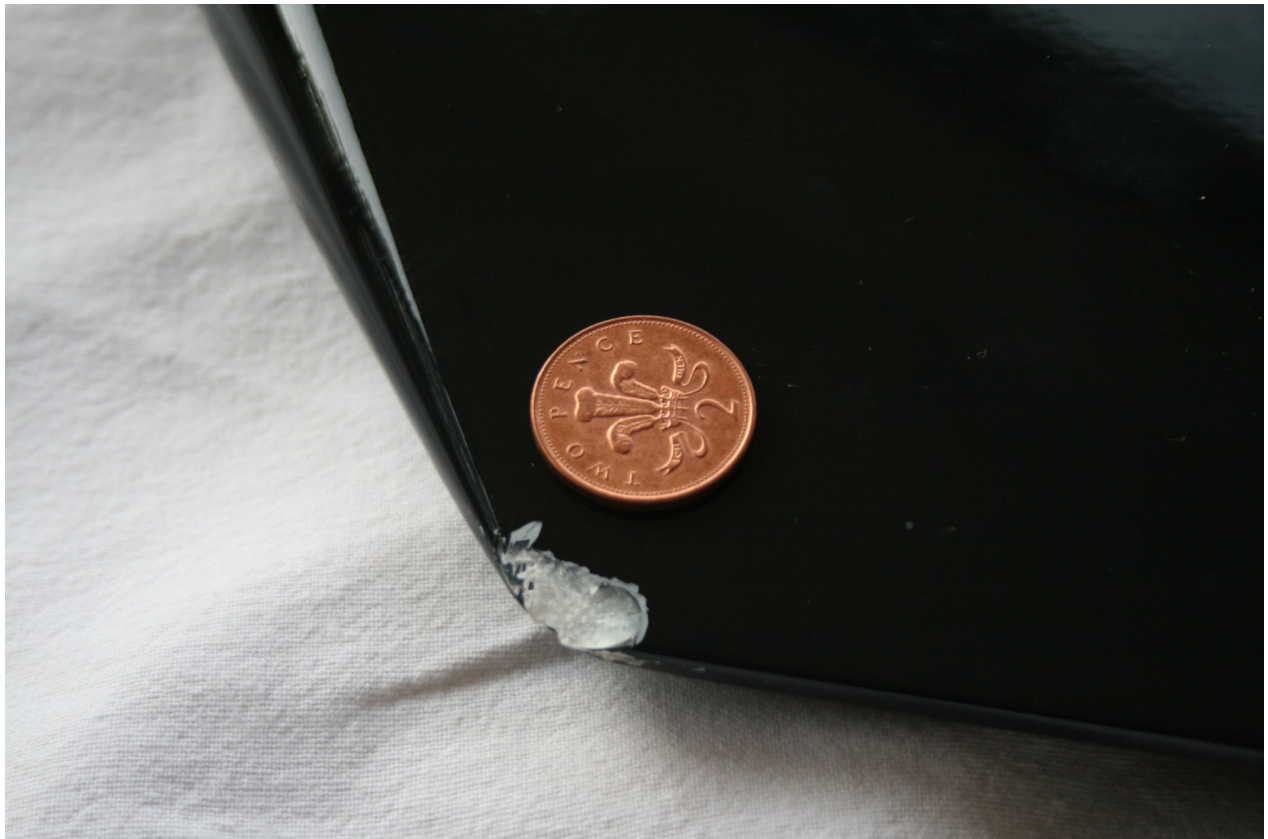
Contact between rudder rear upper tip and rotor whilst hard landing following take off behind the drag curve. Edge damaged.

This area of the rudder is not considered structural, as it does not connect any two parts together, and carries little loading. There was no sign of any delamination between the two rudder halves. Inspection of the rudder shows no loosening of the fasteners or inserts. Damage is limited to the upper rear edge only.

Original damage

Clean back area to base fibreglass. Repair with gelcoat. Fill, sand as required to return to original form. Repaint.

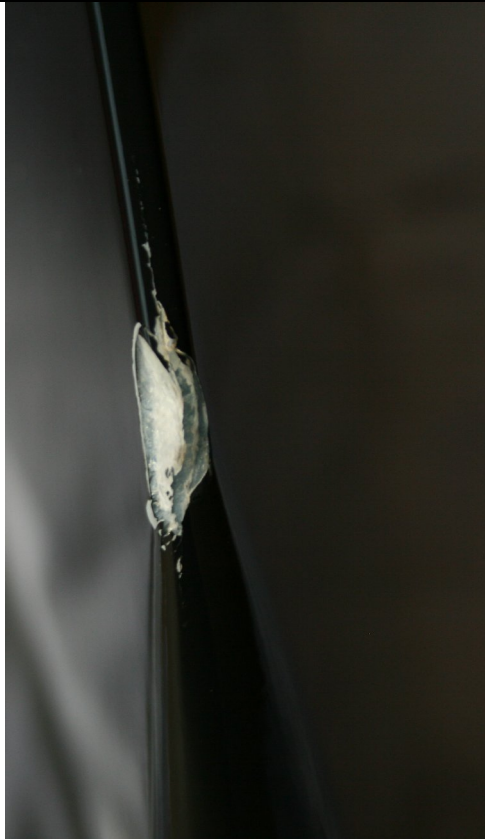
View from top

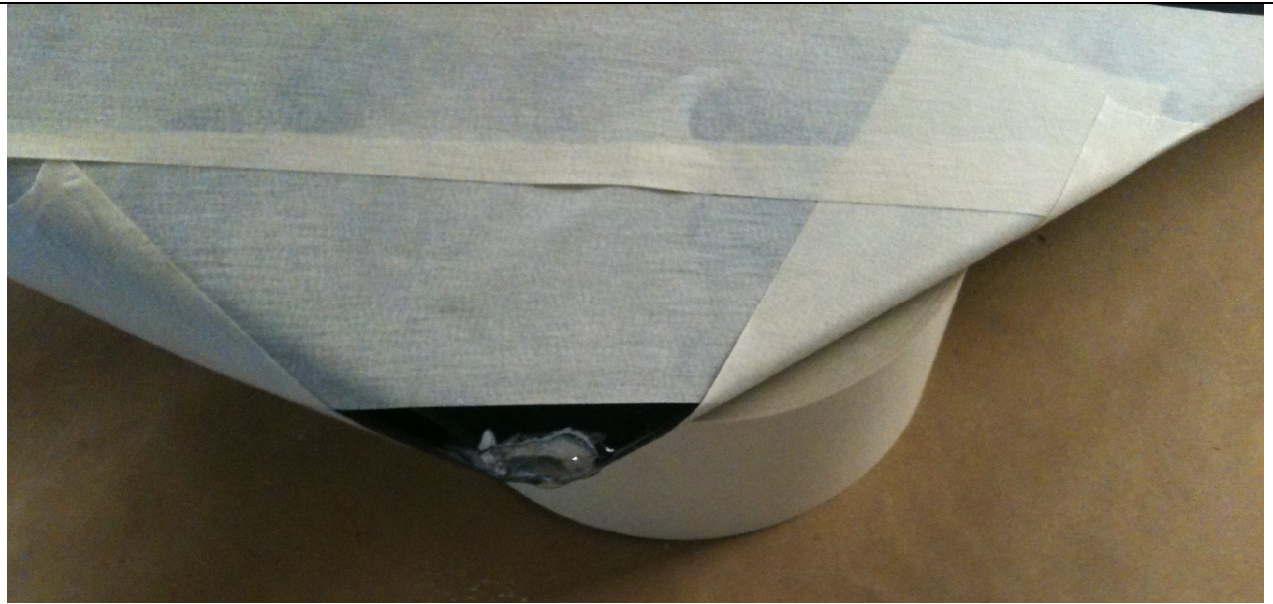
Tip of rudder filled with Wurth ESK -48 for gel repair prior to sanding and painting

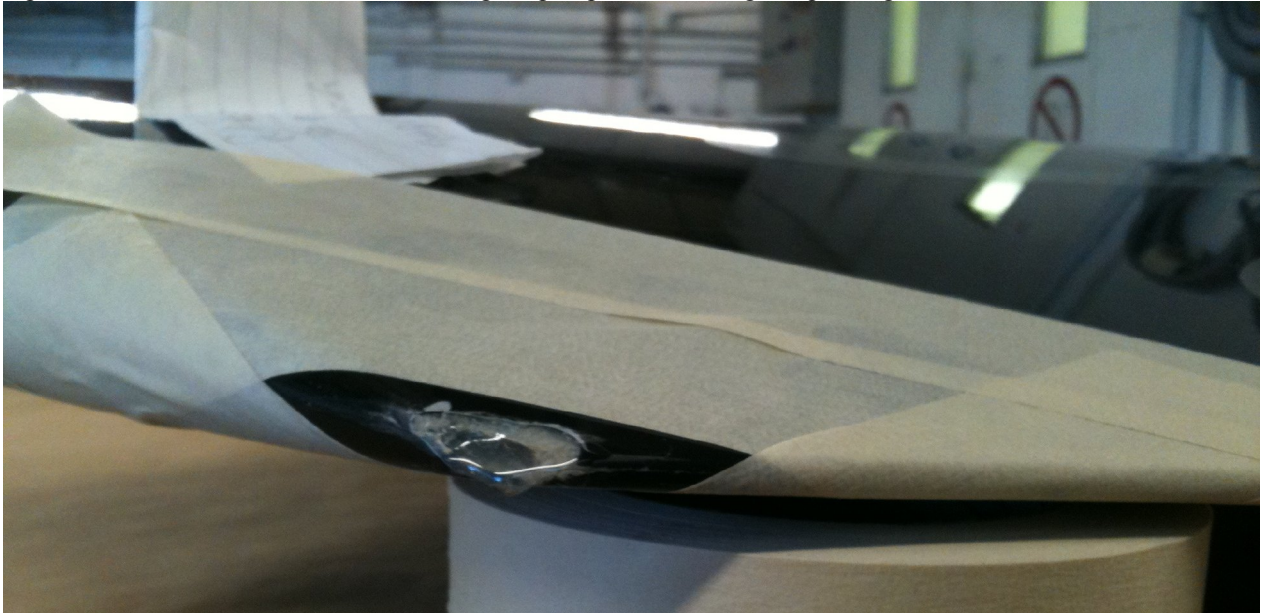
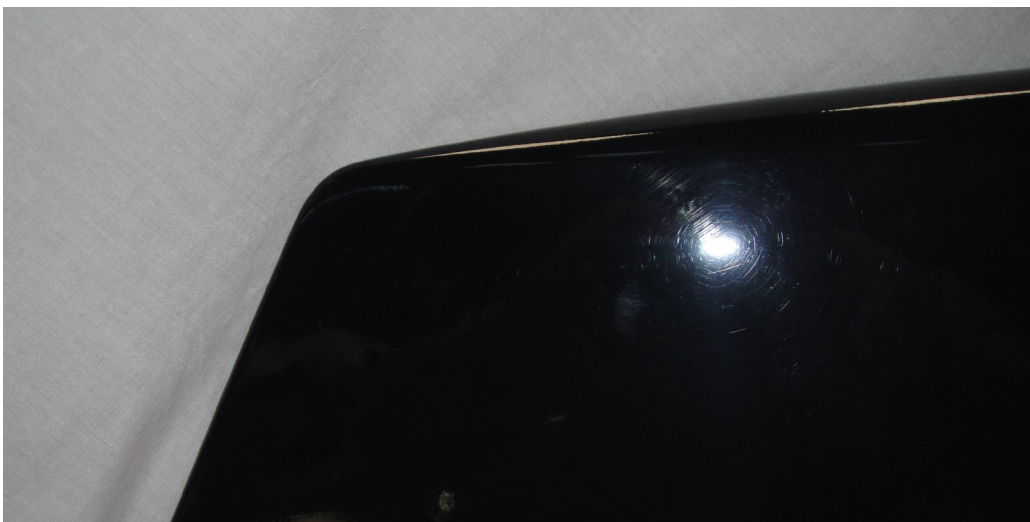
Finished rudder

Quality Inspection requirements after repair: Visual inspection after painting to meet paint standards.
