# RotorSport UK Ltd

## Service Repair Request and Evaluation/Approval

Repair No.: 010 Issue 1

Aircraft type: Calidus

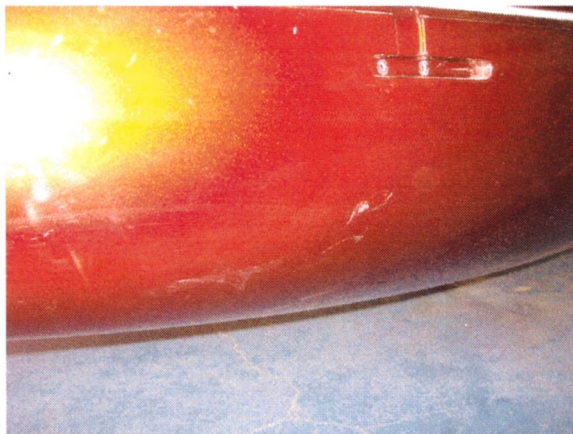
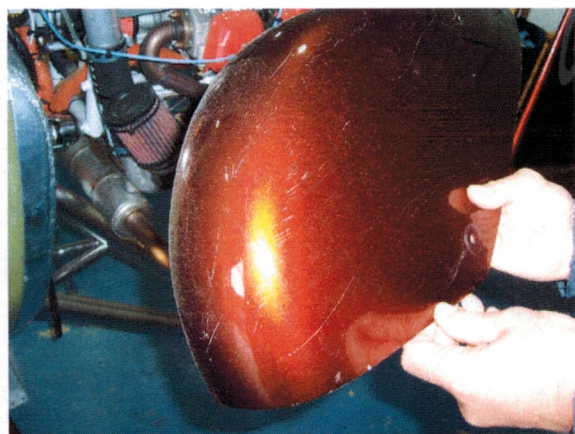
Aircraft collided with a hedge during taxi. Damage was sustained by the enclosure (split in the composite at LHS of nose, surface scratches to paintwork along the left side), the left wheel spat (surface scratches to paintwork) and the propeller (tip damage). NB: propeller is not part of this repair.

Surface scratches in paintwork

<p><u>2) Cosmetic repair of enclosure and left wheel spat</u></p> <p>2.1. Mask, degrease and de-dust the areas to be painted.                  2.2. Using 2-pack polyurethane primer, free-issue water-based colour coat "Rocket Red Flip-Flop", then 2-pack acrylic lacquer, spray the minimum amount of paint to give a satisfactory finish.                  2.3. Air-dry the paint system at room temperature.</p>				
<p>Special tools &amp; Health and Safety requirements, and/or components required for repair:                  None at RSUK, sub-contractors have own specialist equipment.</p>				
<p>Quality Inspection requirements after repair:                  - Visual inspection after painting to meet paint standards                  - Verification of new a/c weight/placard amendment if needed</p>				
<p><i>The technical content of this document is approved under the authority of the UK CAA Design Organisation Approval Ref: DAI/9917/06</i></p>
