RotorSport UK Ltd

Service Repair Request and Evaluation/Approval

Repair No.: 011 Issue 1, 03/10/11	CCAR No.: None Mod approval No. MC-202	Repair classification: MAJOR or MINOR
Aircraft type: MT-03 and MTOsport (all aftermarket only)	Aircraft serial No.: OPEN (first application G-JBRE RSUK/MT03/016)

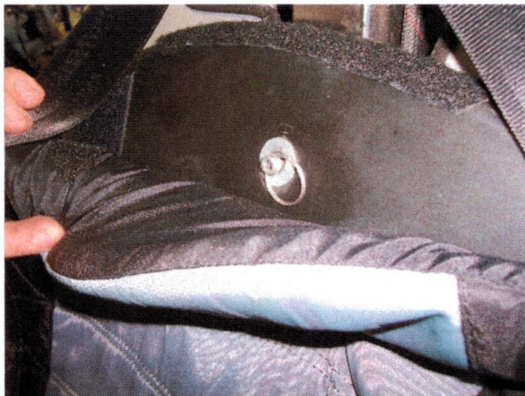
MT-03

1. Remove the seat by unscrewing the upper fastener (socket-head screw with ring on MT-03, thumb-nut on MTOS)
