RotorSport UK Ltd

Service Repair Request and Evaluation/Approval

<p>This form (Part 2 of 2) is the response from RotorSport UK Ltd to a Service Repair and Evaluation/Approval request, which specifies the company authorised repair method. Deviation from this method renders the authorisation ineffective. Upon completion of the repair the repairer must enter details into the logbook/worksheet with the repair number and sign as normal. If any problems with carrying out the work authorised, contact RSUK immediately on 44(0)1926 484556, or email gerry@rotorsport.org.</p>		
Repair No.and Issue: SRA-018 Iss1	CCAR No.: None Mod approval no: MC-247	Repair classification: MAJOR or MINOR
Aircraft type Calidus	Aircraft serial No. OPEN RSUK/CALS/any. First application: G-CGJD	
Repair problem description & cause of problem if known Calidus aircraft have been in service since 2011 and some have suffered damage to the plexiglass canopy. This repair scheme describes how to remove the damaged plexiglass and replace with new under the approval of MC-247.

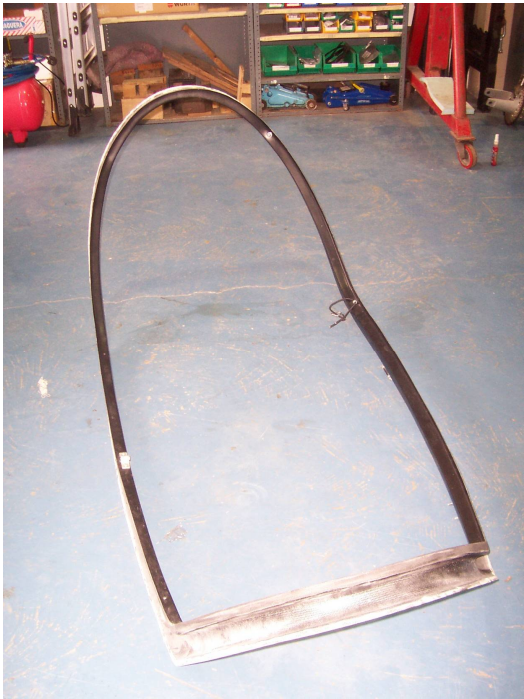
Canopy frame removed from aircraft

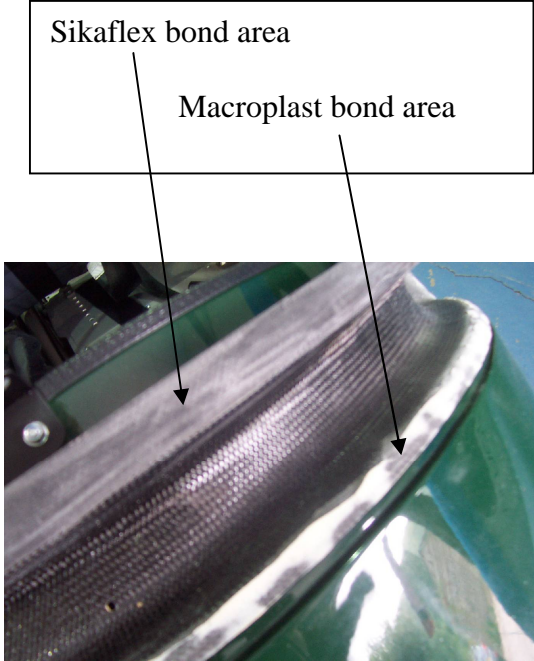
In place after preparation

1. Remove all damaged plexiglass. This is readily accomplished by splitting the plexiglass away from the adhesive bond lines using a thin chisel. Take care not to crack the canopy frame.

2. Using a Dremmel and sanding disc dress the remains of the structural adhesive to a continuous smooth surface with rounded edges. Do not cut through the canopy frame.

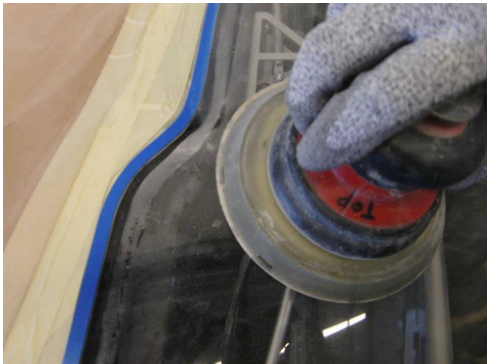
Use of sanding disc to abrade plexiglass

5. Protect the canopy as required with masking tape for full circumference of the canopy
6. Using red scotchbrite and a sanding disc with 360-grade paper abrade the canopy within the marked lines. Thoroughly de-dust the abraded surfaces using dry compressed-air and Amberklene LO30

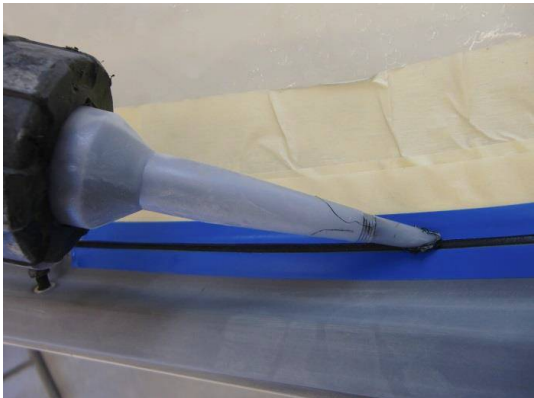
Applying Sikaflex bead

7. Prepare the Macroplast adhesive gun (two pack) and Sikaflex EBT gun (one-pack)
8. Extrude a 6-8mm bead of each adhesive centrally around each bond area

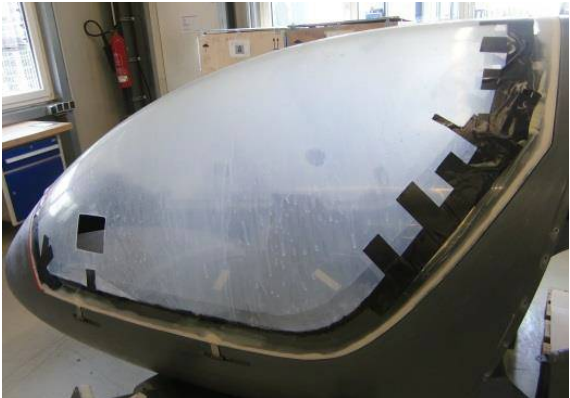
Canopy fixtured onto in-situ frame with foam & tape

9. Carefully place the plexiglass on the frame, add foam packing pieces and pull firmly into place with gaffer-tape.
10. Allow adhesive and mastic to cure overnight in a warm (20 to 30degC) environment

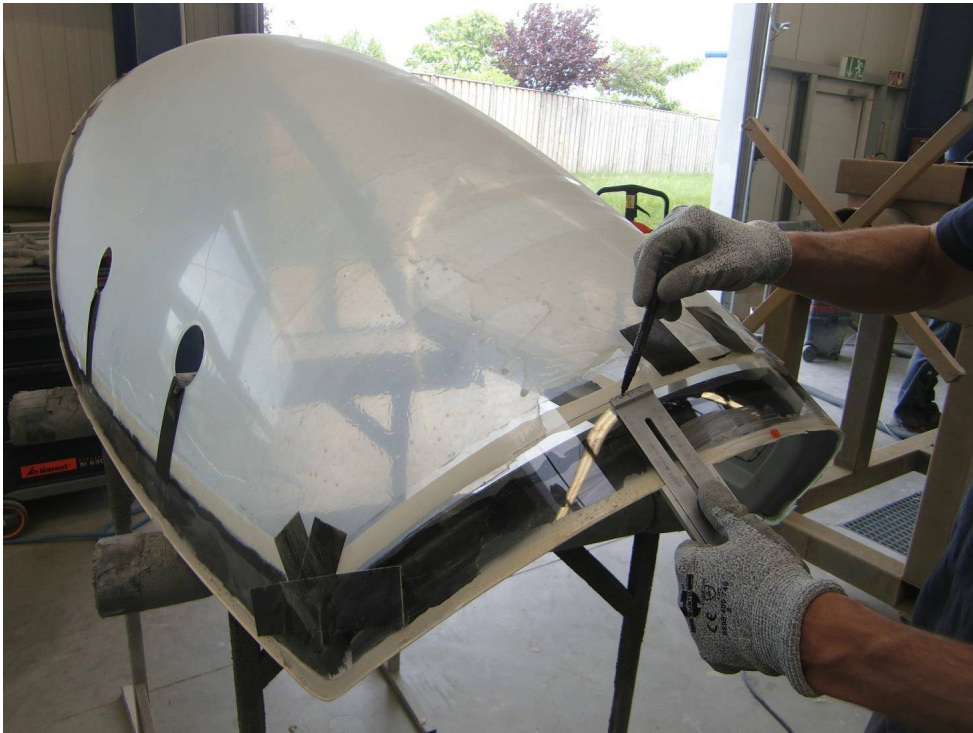
Marking-out for spray-painting

13. Remove the canopy from the aircraft and place on a suitable stand. Mark the required paint line on the canopy with a fine felt-tip pen and the add masking tape as required.

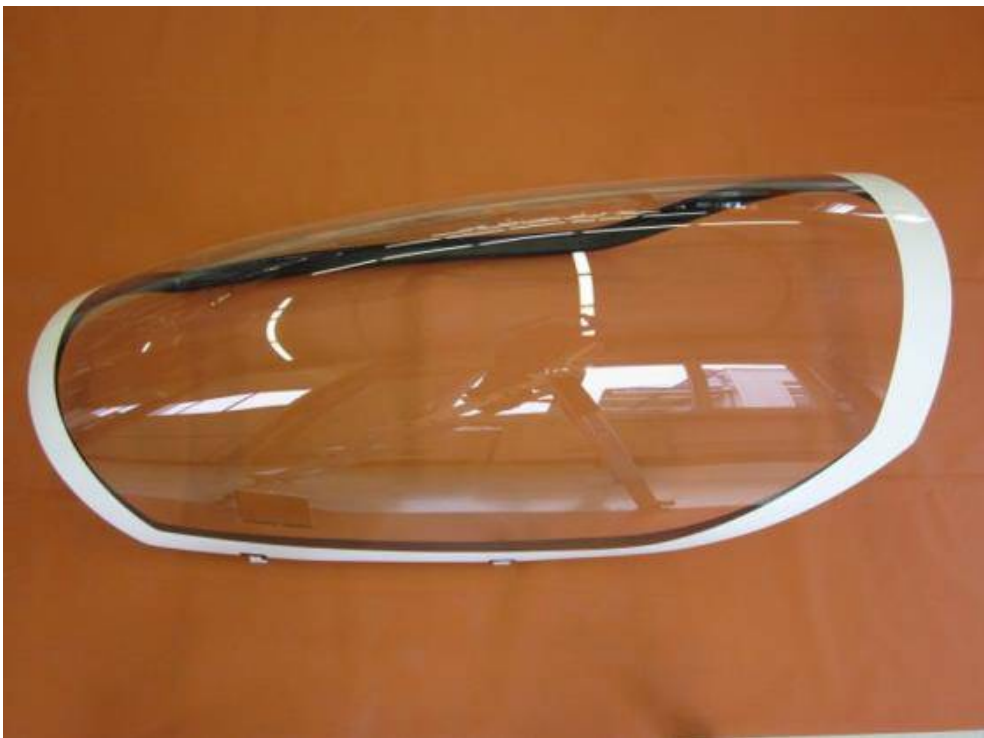
Canopy repair finished (without sun-shield)
