# RotorSport UK Ltd

## Service Repair Request and Evaluation/Approval

<b>Repair No. and Issue: SRA-023 Iss1</b> <b>Calidus suspension bracket bow repair</b>	<b>CCAR No.: 075</b> <b>Mod approval No: None</b>	Repair classification: <b>MAJOR</b> or <b>MINOR</b>
<b>Aircraft type</b> <b>Calidus</b>	<b>Aircraft serial No. RSUK/CALS/005</b> <b>First application: G-YROZ</b>

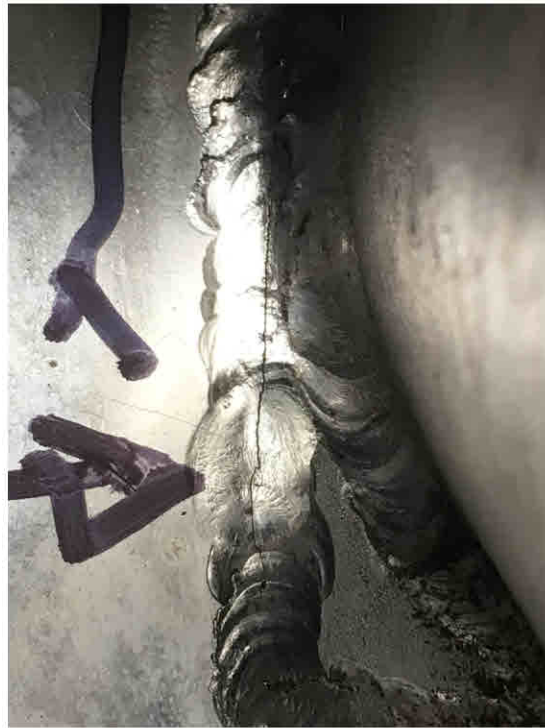
The Calidus suspension bow is attached to the aircraft by way of a 'U' shaped bracket that is welded to the mast structure. During inspection a crack was found in the vertical fillet weld attaching the left rear vertical face to the mast.

Crack position (could be either side of the mast)

Organisation Approval Ref: DAI/9917/06.
<b>Tooling required.</b> Conventional hand tools and TIG welding equipment only
<b>Weight and balance.</b> Not affected
<b>Manuals affected.</b> None affected
<b>Previous modifications affecting this SRA.</b> None
<b>List of materials required to complete this SRA:</b> Weld filler rod only
<b>List of components required to complete this SRA:</b> None
<b>Interchangeability:</b> Not applicable
<b>Parts disposition:</b> Not applicable
<b>Accomplishment instructions/details of the repair:</b>  <ol style="list-style-type: none"><li>1) Remove the fuel tanks and protect any adjacent cables by suitable non-flammable covering.</li><li>2) Using a Dremmel-type tool with small grinding wheel (typ 0.75mm thick) progressively grind-out the length of the crack. Remove all grinding debris and clean-up with Amberclene LO30.</li><li>3) Inspect the plate interface and establish that the crack has not propagated into the mast or keel tube weld.</li><li>4) Weld-up the prepared crack in one continuous pass (see below for welding requirements).</li><li>5) Place an additional vertical weld fillet on the forward side of the plate for the full available length.</li><li>6) Place an identical weld on the other side of the mast, such that both the bracket to mast connection has been symmetrically reinforced with the weld.</li></ol> <p style="text-align: center;"><b><u>Welding requirements (to be carried-out by CAA authorised welder only)</u></b></p> <ol style="list-style-type: none"><li>1. Final preparation of weld area (immediately before welding) Remove any deposits by cleaning with a lint-free cloth and halogen-free solvent (Amberclene LO30). Remove any surface debris by brushing with a stainless-steel wire-brush.</li><li>2. Welding Set the TIG welder for job +ve, electrode -ve. Using an electrode 2.4mm diameter, filler metal 316 stainless steel and heat-setting 60-70amps produce a continuous fillet weld in a single run.</li></ol>

<p>produce a continuous fillet weld in a single run. Ensure that filler metal is present in the whole welded length so that a joint "fused only" is not created.</p> <p>3. Clean-up Remove burn marks from the weld and areas adjacent using a stainless-steel wire-brush followed by Scotchbrite pads or rubbing blocks if required. Do not use any acid treatment for clean-up. Do not dress the weld by grinding, leave the visible fillet intact.</p> <p>4. Inspection Using a magnifying glass at least 4x and good illumination inspect the weld to ensure that there is a high build for the whole length of the weld with no inclusions or voids present and that the start and end of the run are of uniform shape.</p>									
<p><b>Reference to other documentation:</b></p> <p>No modification has been raised as it is considered that this repair reinstates the joint to the original specification.</p>									
<p><b>Test and inspection records:</b></p> <p>Complete attached worksheet</p>									
<p><b>Special Tools &amp; Health and Safety requirements, and/or components required for repair:</b></p> <p>No special tools or components required</p>									
<p><b>Quality Inspection requirements after repair:</b></p> <p>Visual inspection required as described above</p>									
<p><b>Flight test requirements after repair:</b></p> <p>No flight test required</p>									
<p><b>Documentation completion:</b></p> <ol style="list-style-type: none"> <li>1. Complete the SRA worksheet attached</li> <li>2. After embodiment of this repair SRA-023 the authorised engineer/welder must make an entry in the airframe logbook white pages stating that the repair has been embodied.</li> </ol>									
<p><b>Service repair authorised by: (name, signature, and date of signature)</b></p> <table border="1" style="width: 100%; border-collapse: collapse;"> <tr> <td style="width: 20%; padding: 5px; vertical-align: top;"> <p>Quality Control Manager</p>   </td> <td style="width: 20%; padding: 5px; vertical-align: top;"> <p>Engineering Manager</p>   <div style="font-size: 8px; margin-top: 5px;">                     Graham Shaw                      Sep 28 2017 11:39 AM    </div> </td> <td style="width: 20%; padding: 5px; vertical-align: top;"> <p>Chief Test Pilot (where an effect on flight performance or safety)</p> <p>None required</p> </td> <td style="width: 20%; padding: 5px; vertical-align: top;"> <p>CVE</p>   <div style="font-size: 8px; margin-top: 5px;">                     David Starkey                      Sep 28 2017 4:24 PM    </div> </td> <td style="width: 20%; padding: 5px; vertical-align: top;"> <p>Head of Airworthiness</p>   <p style="font-size: 1.2em; margin-top: 10px;">29/9/2017</p> </td> </tr> </table>					<p>Quality Control Manager</p>  	<p>Engineering Manager</p>   <div style="font-size: 8px; margin-top: 5px;">                     Graham Shaw                      Sep 28 2017 11:39 AM    </div>	<p>Chief Test Pilot (where an effect on flight performance or safety)</p> <p>None required</p>	<p>CVE</p>   <div style="font-size: 8px; margin-top: 5px;">                     David Starkey                      Sep 28 2017 4:24 PM    </div>	<p>Head of Airworthiness</p>   <p style="font-size: 1.2em; margin-top: 10px;">29/9/2017</p>
<p>Quality Control Manager</p>  	<p>Engineering Manager</p>   <div style="font-size: 8px; margin-top: 5px;">                     Graham Shaw                      Sep 28 2017 11:39 AM    </div>	<p>Chief Test Pilot (where an effect on flight performance or safety)</p> <p>None required</p>	<p>CVE</p>   <div style="font-size: 8px; margin-top: 5px;">                     David Starkey                      Sep 28 2017 4:24 PM    </div>	<p>Head of Airworthiness</p>   <p style="font-size: 1.2em; margin-top: 10px;">29/9/2017</p>					
<p><b>Document effectivity date:</b></p> <p>26<sup>th</sup> Sept 2017</p>
