RotorSport UK Ltd

Service Repair Request and Evaluation/Approval

Repair No. and Issue: SRA-024 Iss1
Calidus bow attachment repair

Aircraft type
Calidus

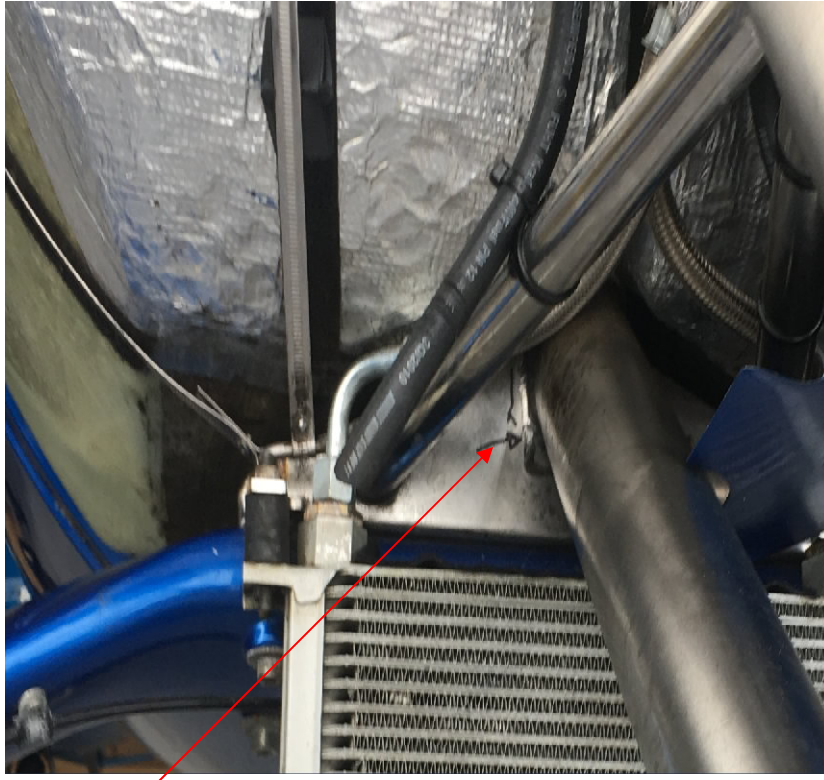
It has previously been found that the vertical fillet weld attaching the rear vertical face to the mast may sustain a crack (see SRA-023) but this repair SRA-024 relates to a crack in the bracket itself. However, the bracket should be carefully inspected for either crack.

Crack position for SRA-023 (could be either side of the mast)

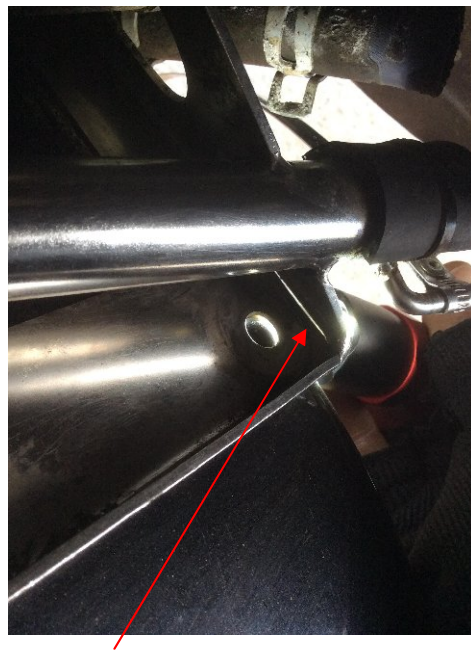
Crack position for this SRA-024 (mounting bolt removed and illuminated from rear)

Limitations on implementation 1) The weld repair must be made by a CAA or RSUK authorised welder. 2) The crack must not have propagated into the mast or keel tube weld and the plate must not be distorted. If found such contact RotorSport UK Ltd.
Approval statement. The technical content of this document is approved under the authority of the UK CAA Design Organisation Approval Ref: DAI/9917/06.
Tooling required. Conventional hand tools and TIG welding equipment only
Weight and balance. Not affected
Manuals affected. None affected
Previous modifications affecting this SRA. None
List of materials required to complete this SRA: Weld filler rod only
List of components required to complete this SRA: None
Interchangeability: Not applicable
Parts disposition: Not applicable
Accomplishment instructions/details of the repair: <ol style="list-style-type: none">1) Remove the fuel tanks and protect any adjacent cables by suitable non-flammable covering.2) Jack the aircraft securely so that the suspension bow may be released. If required for access release the oil cooler, move to one side and protect from weld spatter3) Stop-drill the crack ends 1.5 – 2.0mm4) Using a Dremmel-type tool with small grinding wheel (typ 0.75mm thick) progressively grind-out the length of the crack in an opposing V-shape 1 – 1.5mm wide. Remove all grinding debris and clean-up with Amberclene LO30.5) Inspect the plate interface and establish that the crack has not propagated into the mast or keel tube weld.6) Weld-up the prepared crack in two opposing passes, one inside and one outside of the bracket (see below for welding requirements).7) Inspect the resulting welds (see below)8) Clean-up and re-assemble the aircraft using new fasteners.

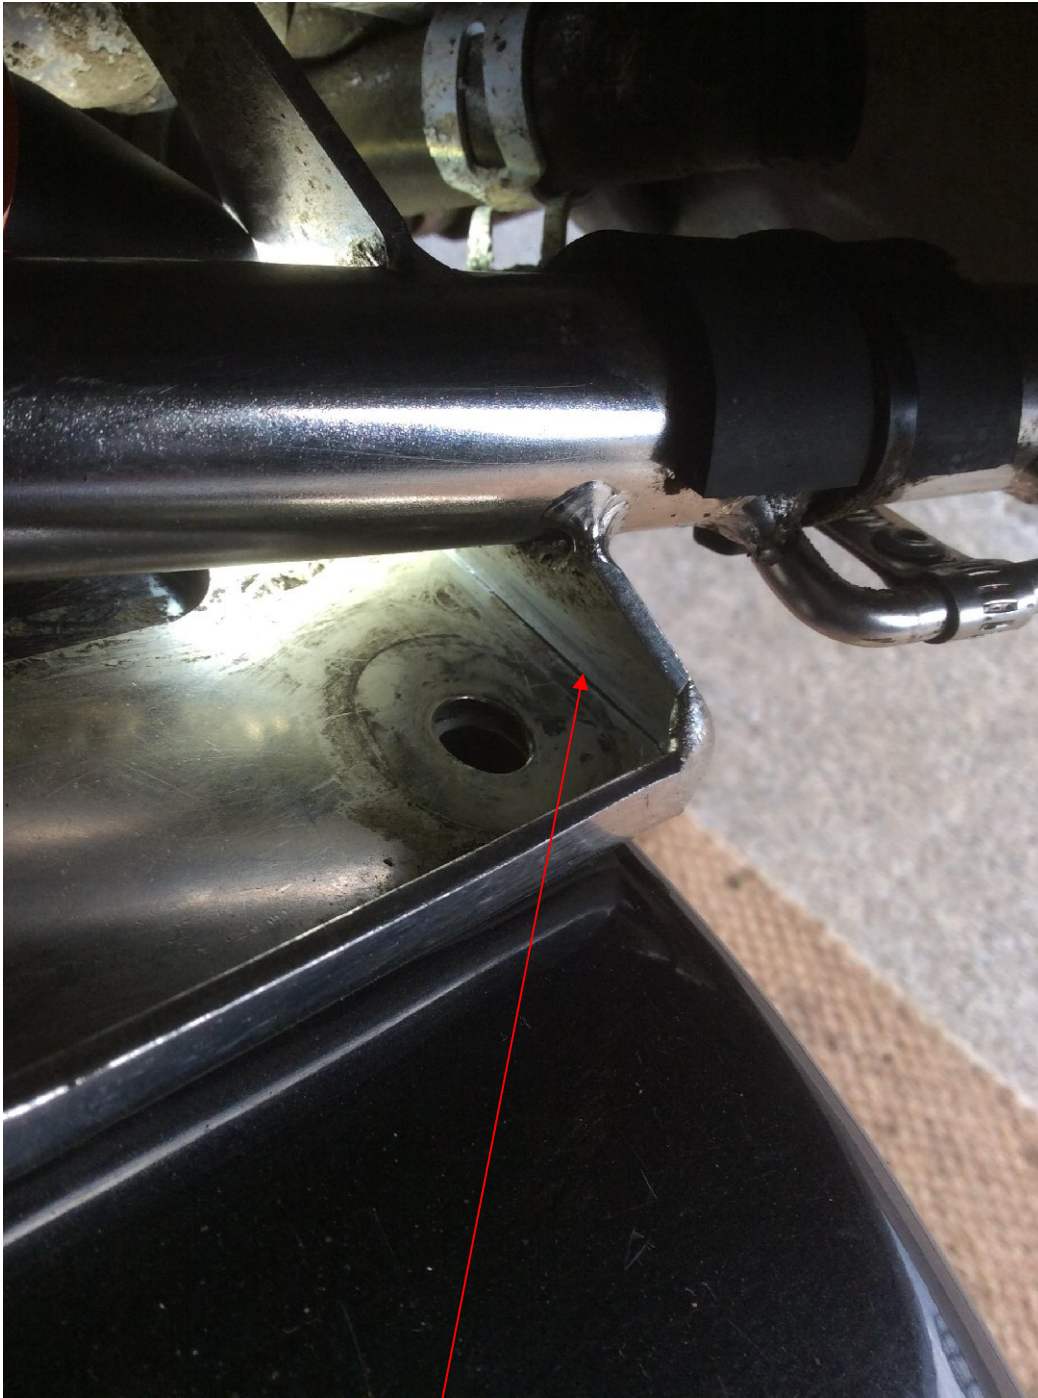
Magnified view of crack for this SRA-024
