RotorSport UK Ltd

Service Repair Request and Evaluation/Approval

Repair No. and Issue: SRA-024 Iss1 Calidus bow attachment repair	CCAR No.: None Mod approval No: None	Repair classification: MAJOR or MINOR
Aircraft type Calidus	Aircraft serial No. RSUK/CALS/006 First application: G-KASW

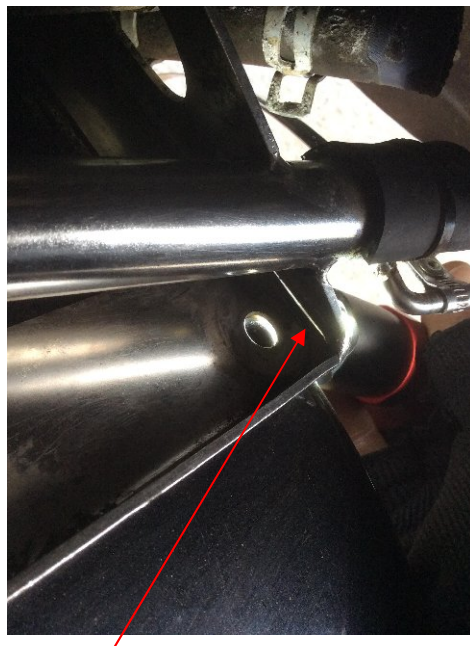
It has previously been found that the vertical fillet weld attaching the rear vertical face to the mast may sustain a crack (see SRA-023) but this repair SRA-024 relates to a crack in the bracket itself. However, the bracket should be carefully inspected for either crack.

Crack position for this SRA-024 (mounting bolt removed and illuminated from rear)

Limitations on implementation 1) The weld repair must be made by a CAA or RSUK authorised welder. 2) The crack must not have propagated into the mast or keel tube weld and the plate must not be distorted. If found such contact RotorSport UK Ltd.
Approval statement. The technical content of this document is approved under the authority of the UK CAA Design Organisation Approval Ref: DAI/9917/06.
Tooling required. Conventional hand tools and TIG welding equipment only
Weight and balance. Not affected
Manuals affected. None affected
Previous modifications affecting this SRA. None
List of materials required to complete this SRA: Weld filler rod only
List of components required to complete this SRA: None
Interchangeability: Not applicable
Parts disposition: Not applicable
Accomplishment instructions/details of the repair: <ol style="list-style-type: none">1) Remove the fuel tanks and protect any adjacent cables by suitable non-flammable covering.2) Jack the aircraft securely so that the suspension bow may be released. If required for access release the oil cooler, move to one side and protect from weld spatter3) Stop-drill the crack ends 1.5 – 2.0mm4) Using a Dremmel-type tool with small grinding wheel (typ 0.75mm thick) progressively grind-out the length of the crack in an opposing V-shape 1 – 1.5mm wide. Remove all grinding debris and clean-up with Amberclene LO30.5) Inspect the plate interface and establish that the crack has not propagated into the mast or keel tube weld.6) Weld-up the prepared crack in two opposing passes, one inside and one outside of the bracket (see below for welding requirements).7) Inspect the resulting welds (see below)8) Clean-up and re-assemble the aircraft using new fasteners.
