# RotorSport UK Ltd

## Service Repair Request and Evaluation/Approval

**Repair No. and Issue:** SRA-025 Iss1  
Calidus bow attachment repair

**Aircraft type**  
Calidus

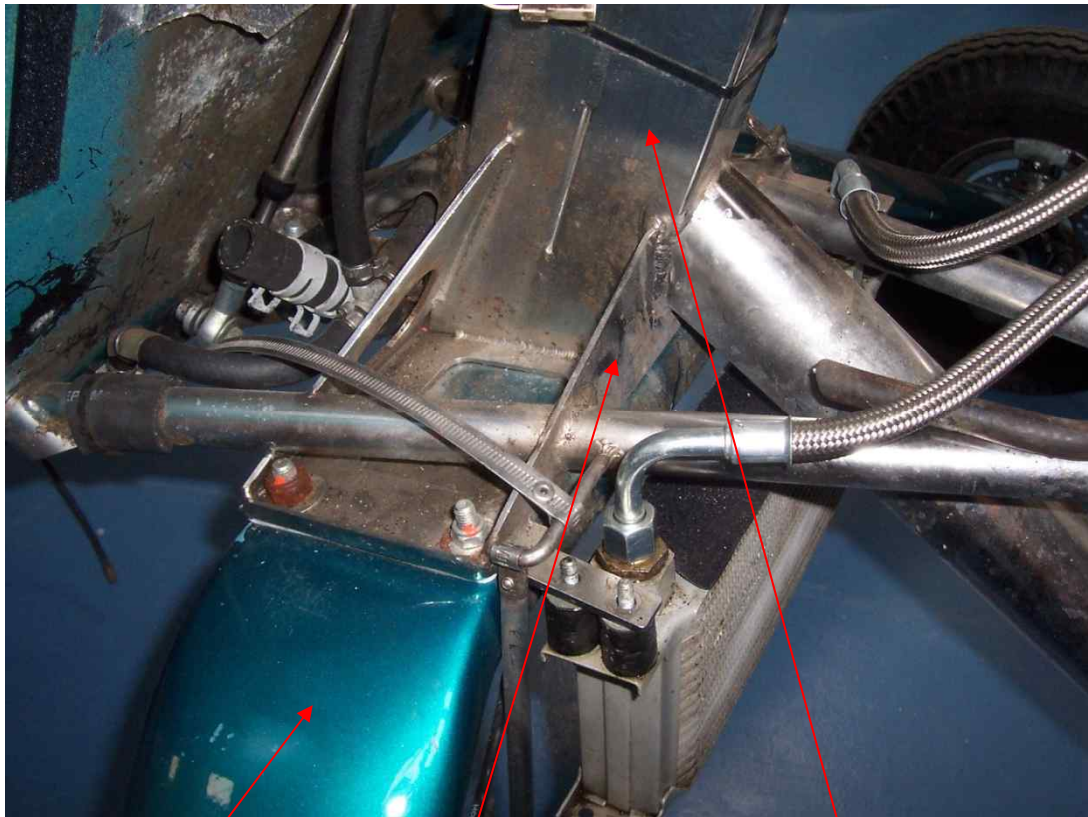
The Calidus suspension bow is attached to the aircraft by way of a 'U' shaped bracket that is welded to the mast structure.

Bow

Bracket

Mast

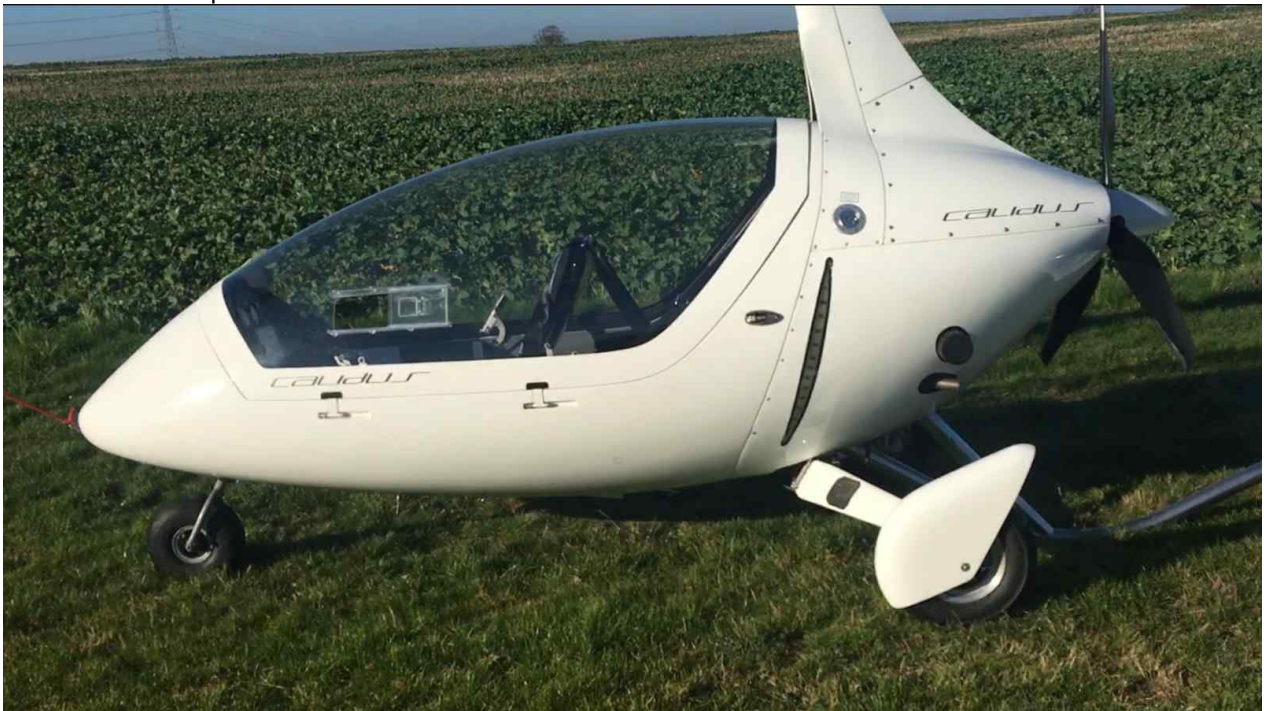
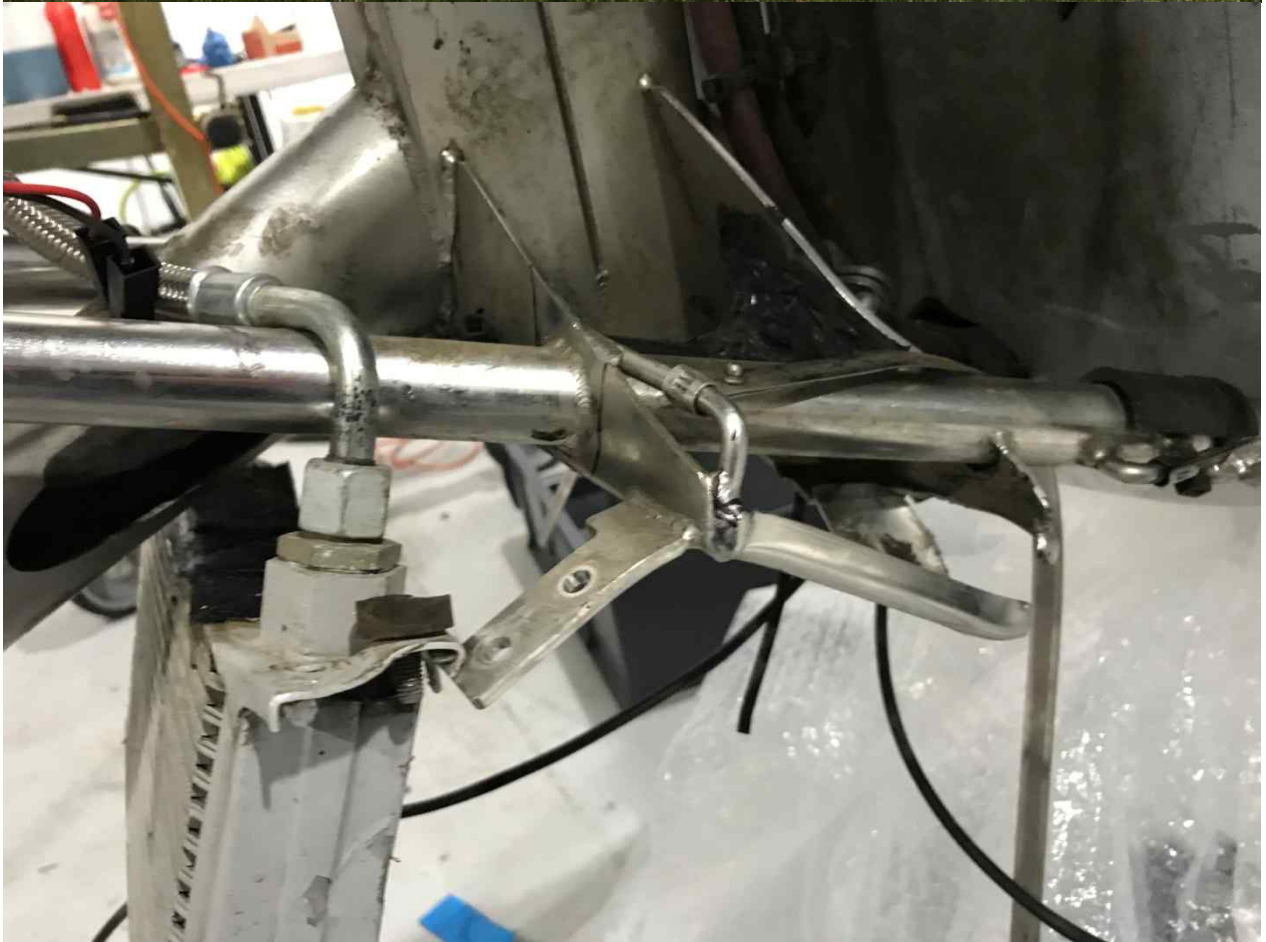
In one instance the bracket has become partially detached from the mast structure, such that the bracket and bow were displaced rearwards.

View of bow mounting with suspension bow removed.

- 1) The weld repair must be made by a CAA or RSUK authorised welder.
- 2) The crack must not have propagated into the mast or keel tube weld. If found such contact RotorSport UK Ltd.

- 5) Using suitable tools, remove the suspension bow mtg bracket. Grind the welds as flush a practical to the base metal surface. The mast side stays normally pass through the bracket, so material above the tube is left in place to match the corresponding cut in the bracket. Trim the front and rear centre slot in the bracket to match the airframe. See photos. Ensure that the new bracket fits well to the assembly with no more than 1mm gap between the bottom of the mast and the bracket.

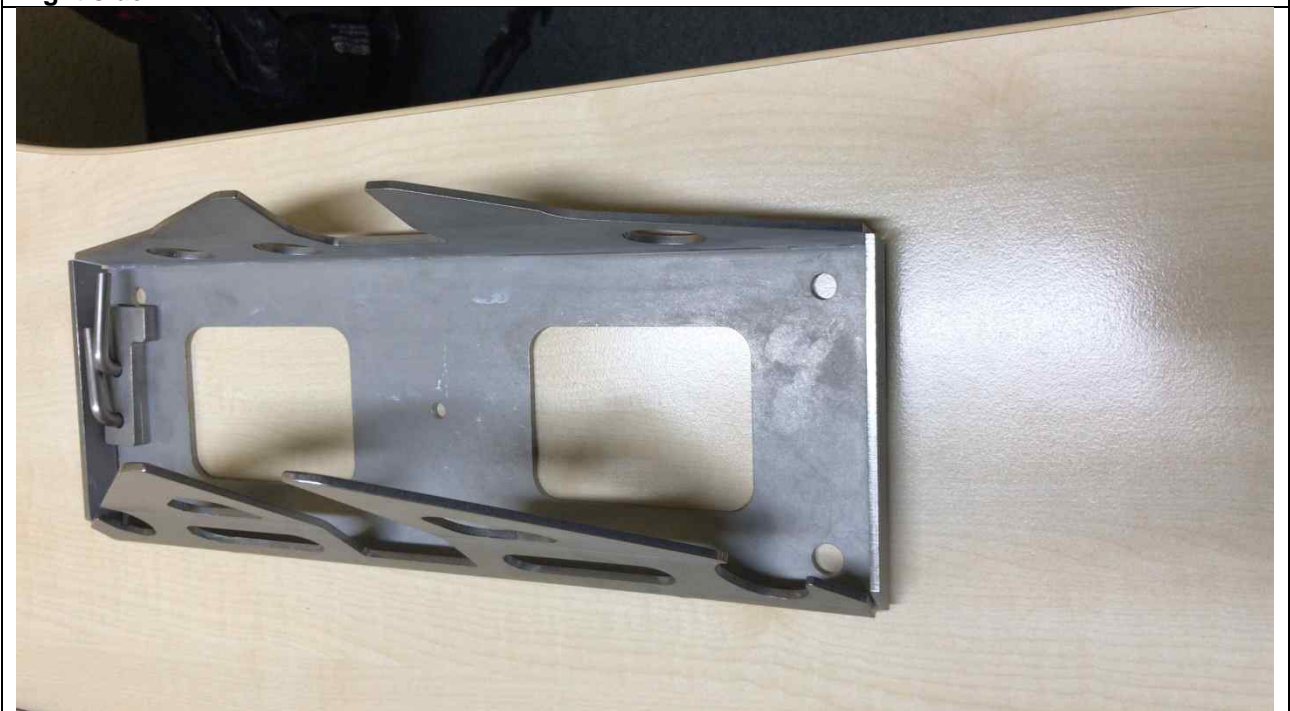
New bracket.  
Oil cooler mounting plate shown lying on top.  
The wireforms shown are not required.  
New bracket fitted, ready to clean up and weld

- 8) Before welding the bracket to the aircraft, first weld the oil cooler mounting plates to the bracket. The easiest way is to attach these to an oil cooler to ensure the centre position is correct, and then tack them onto the bracket at the correct angle and position. See sketch. They are welded for the full plate circumference.
- 9) Position the bracket onto the airframe with a jack under the bracket to hold it firmly in position, Ensure the bracket is as in line as possible with the airframe and tack the bracket in place.
- 10) Weld the centre portion to the airframe as per photos.

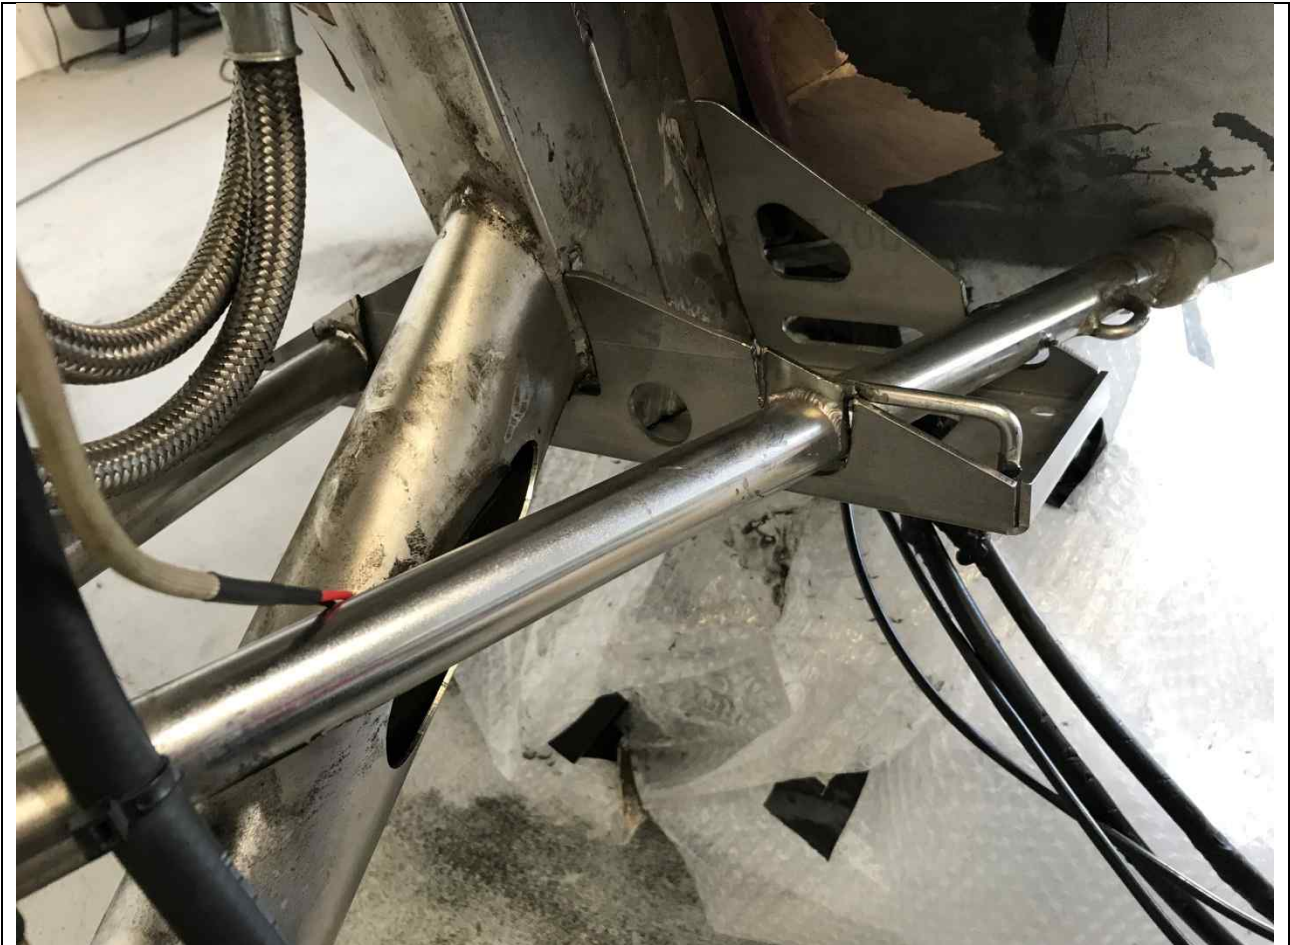
**Note how the area where the tube passes through the bracket is slotted to allow assembly. The bracket material above the tube at the bracket rear is retained and welded back to the new bracket.**

**The tank strap stay (the formed wire) is retained and welded back into place.**

**Note that this later generation bracket is welded to the edge of the mast tubes rather than the middle, and welded both sides.**

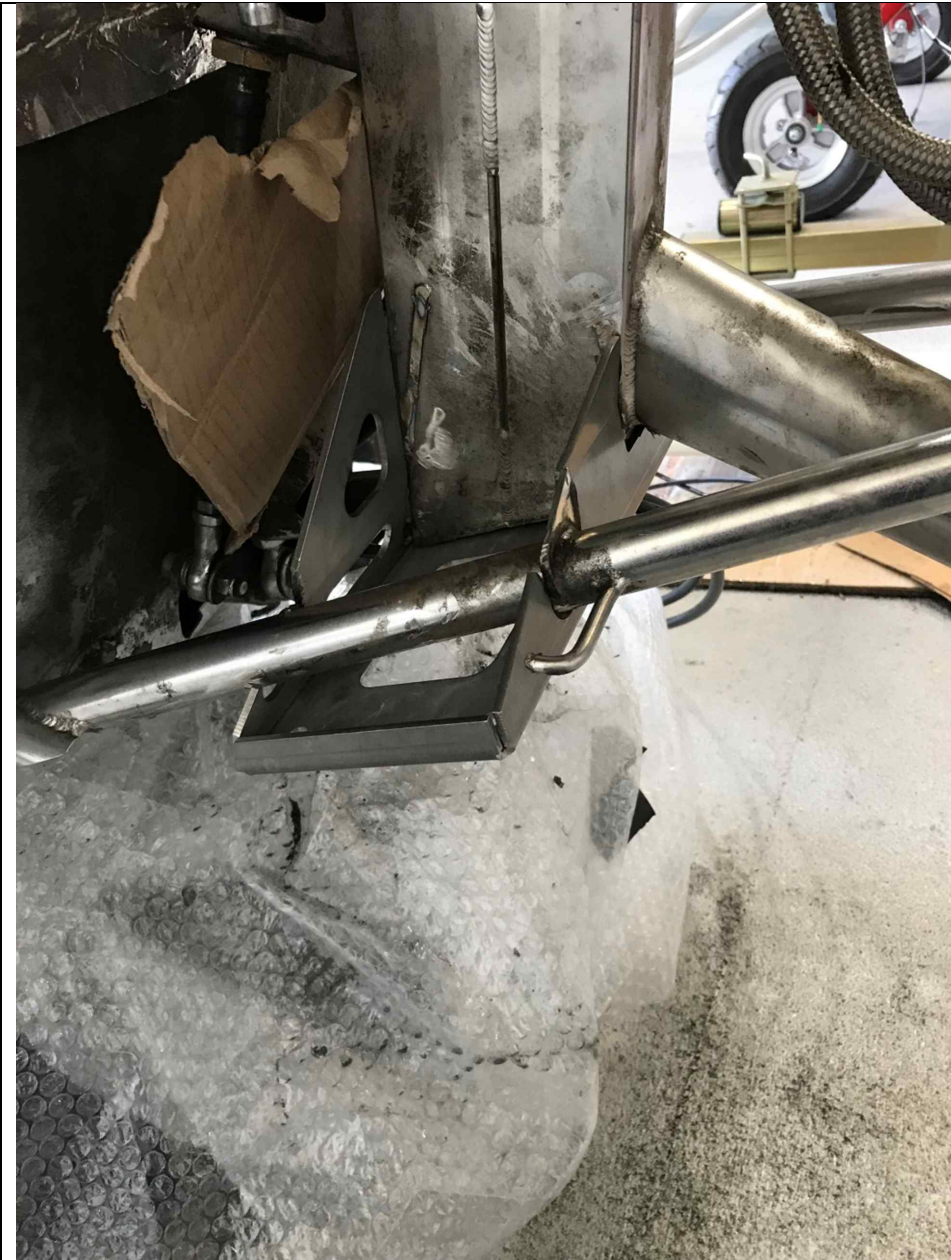
**New bracket finished, ready for re-assembly**

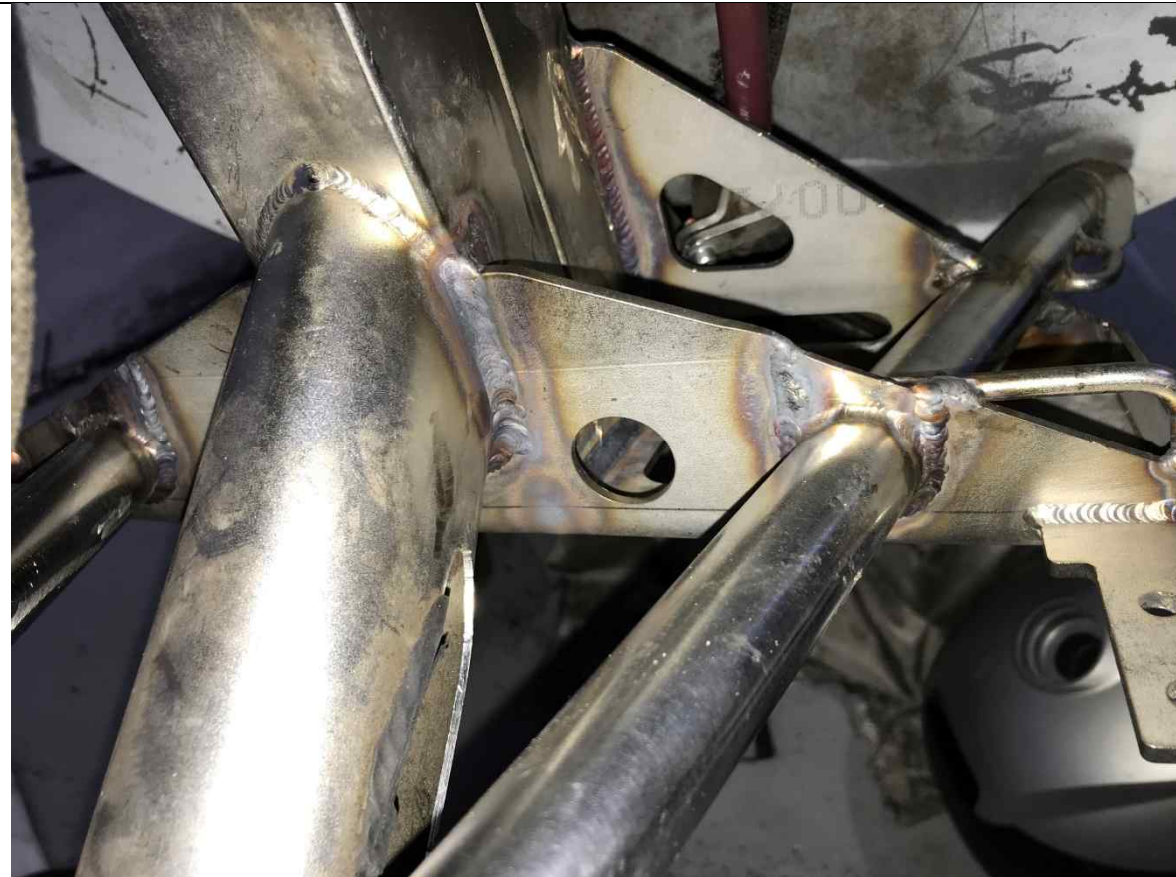
View showing the original bracket remains welded to the new bracket

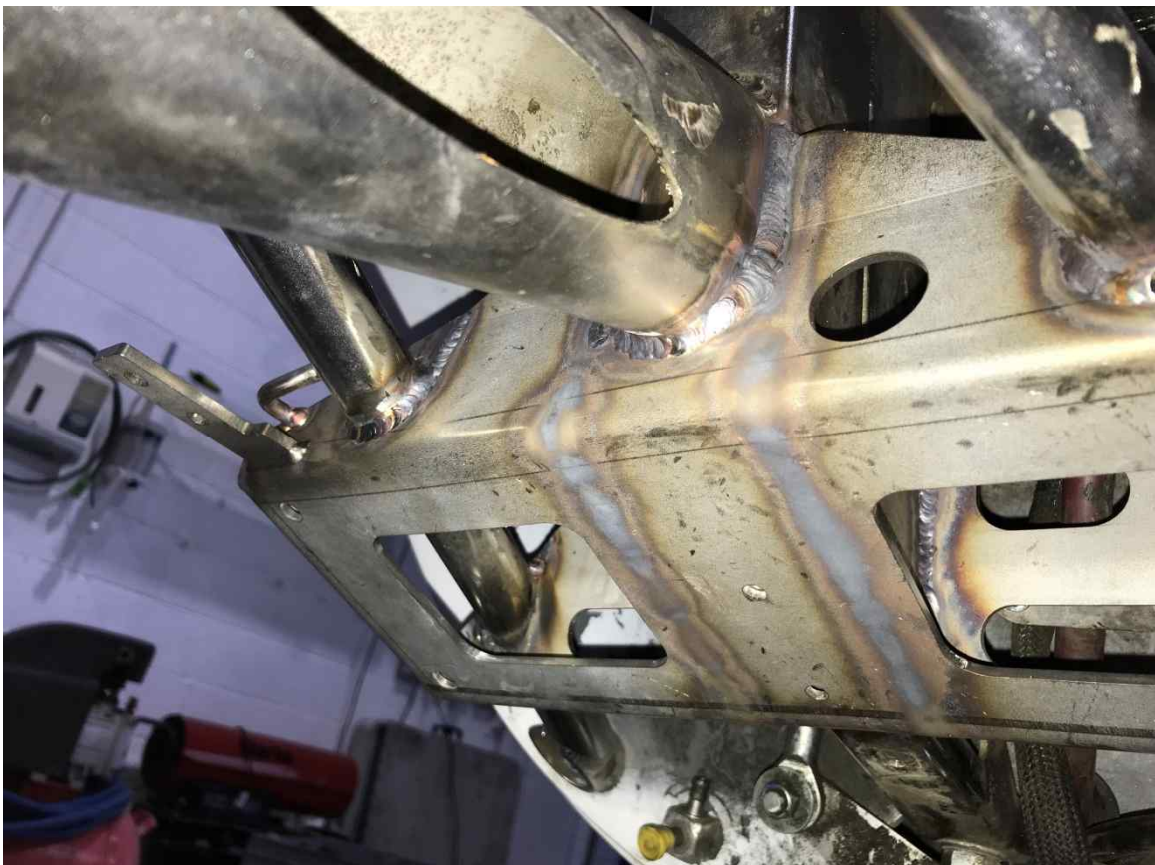
Underside view showing the weld to the keel tube.

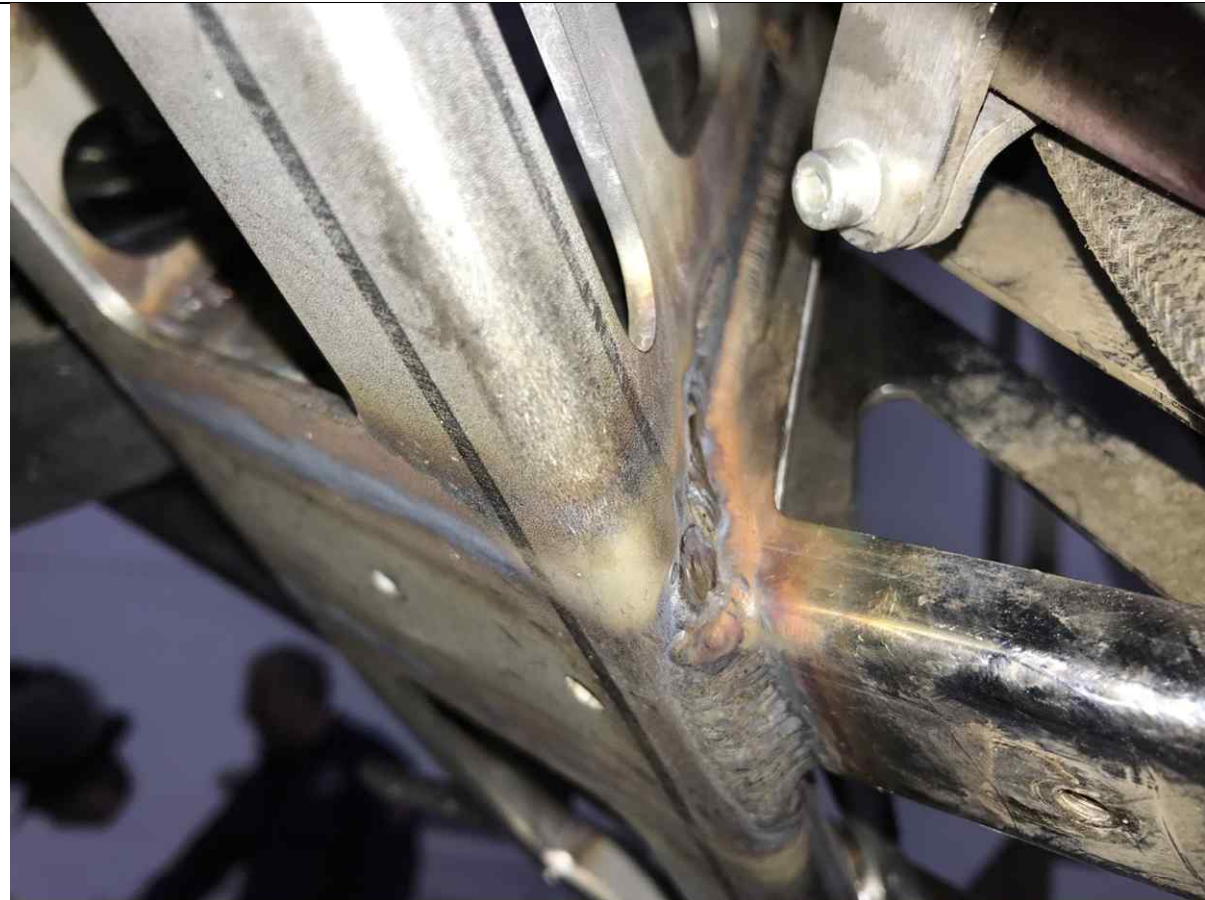
Underside view of the bracket weld to the front control stay

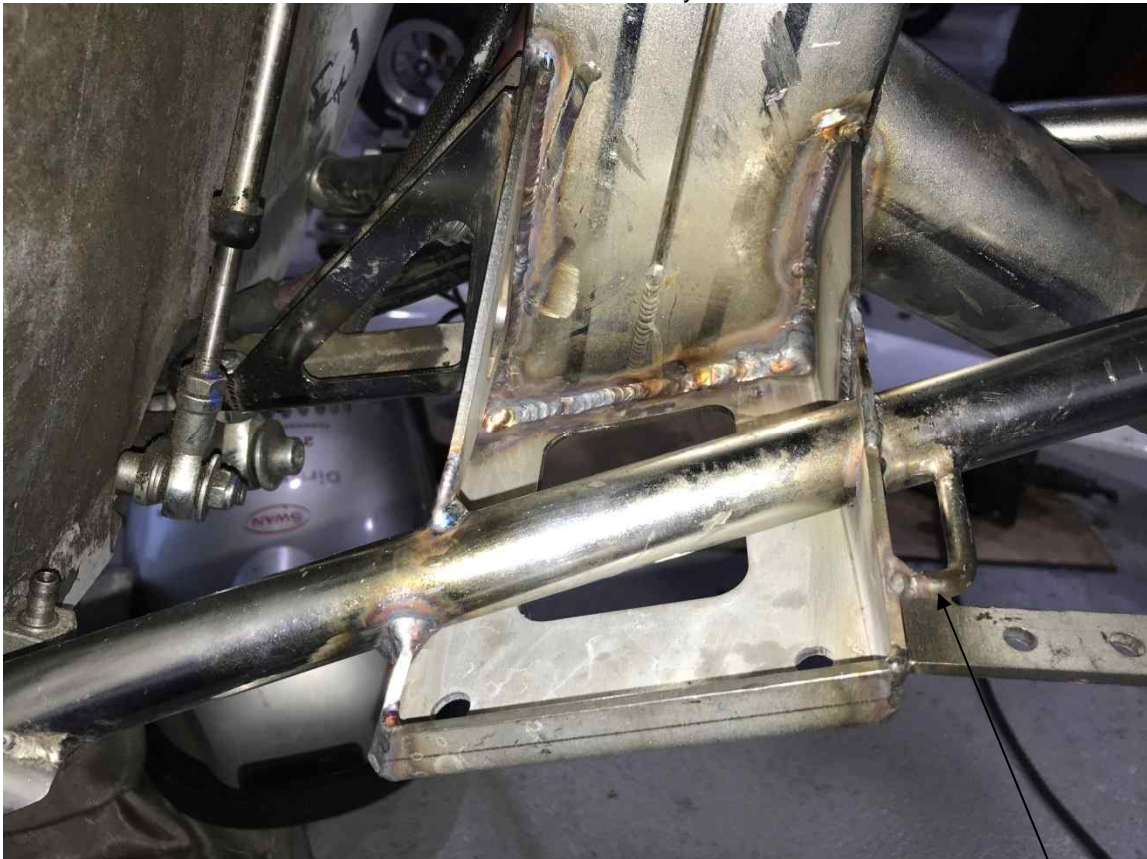
View of left bracket side. Note the original fuel tank strap bracket welded back into place

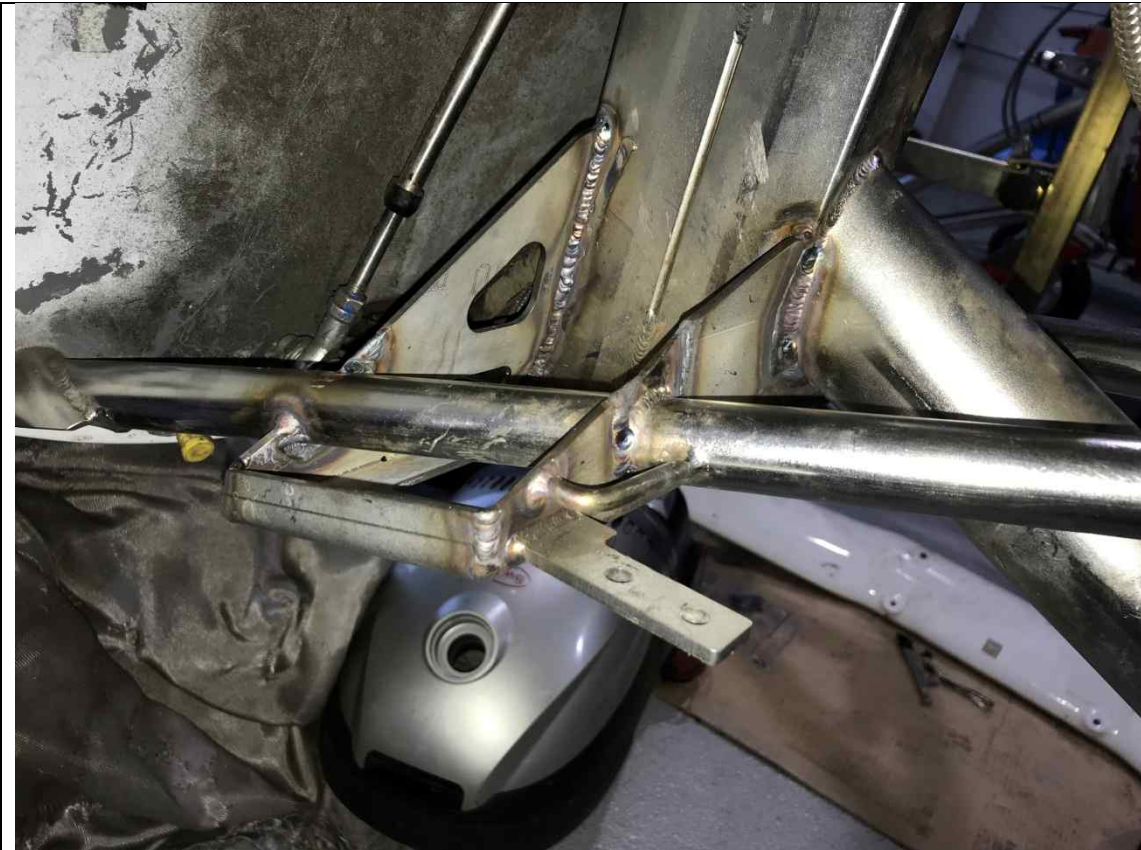
Left side bracket. Note all four bracket corners are welded too.

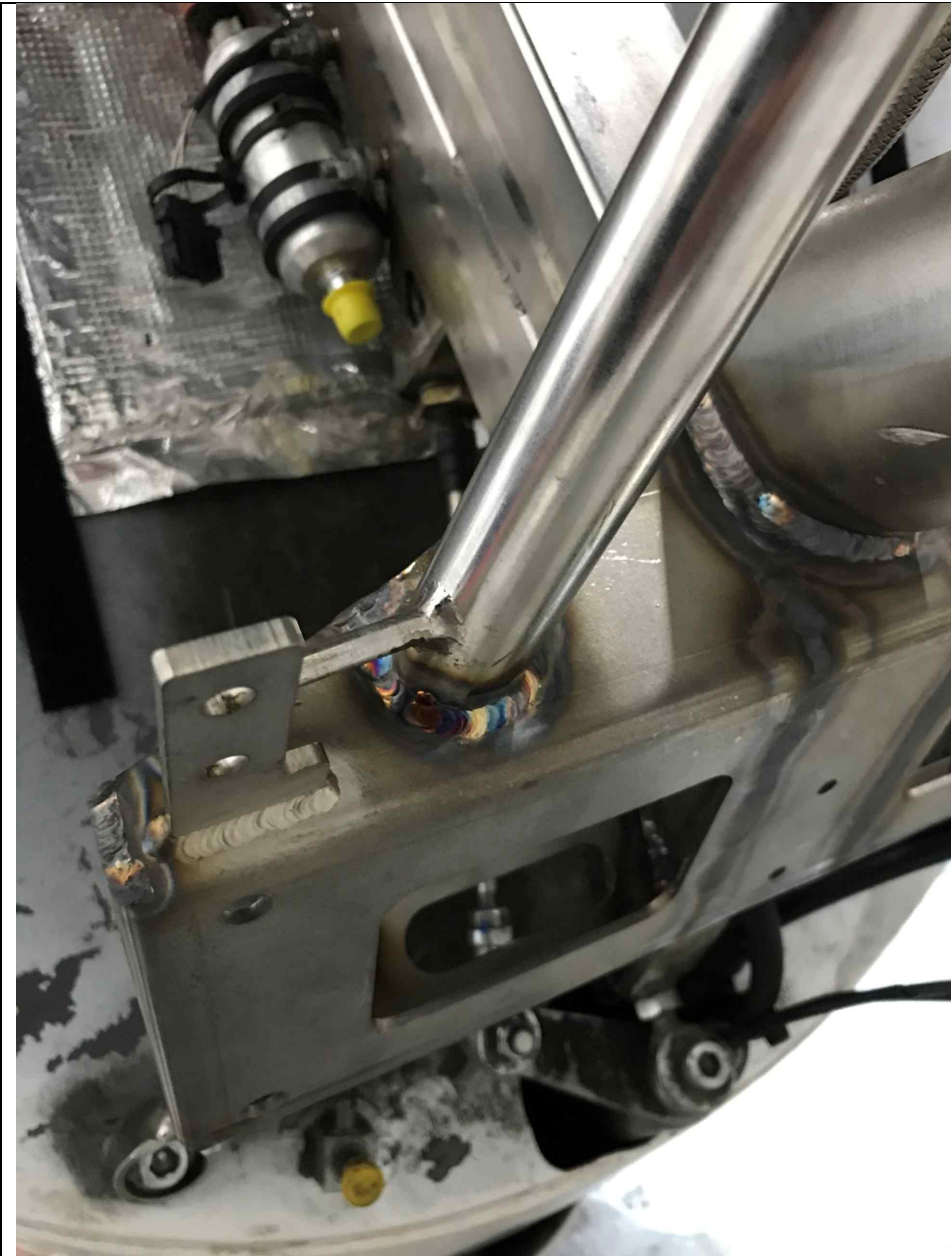
Rear view looking forward showing weld around the brace tubes (4 places) and the oil cooler mounting bracket.
