RotorSport UK Ltd Service Bulletin

Title: Pre-rotator clutch torque check		
SB No.: 087 Iss2	Related documents MC No: None CCAR No.: None	Compliance Category: OPTIONAL or RECOMMENDED or MANDATORY
Applicability		
Aircraft type & model:	Aircraft serial Nos. affected:	
Cavalon	Any a/c manufactured before 7/14	
Calidus	Any a/c manufactured after RSUK/CALS/021 and before 7/14. Any aircraft retrofitted with Pneumatic Coupling III under MC-212	
This form is the response from RotorSport UK Ltd either against a problem found in the product in service requiring a containment or rectification action, or as service information for aircraft modification incorporation. For help, contact RotorSport on 44(0)1588 650769, or email info@rotorsport.org.		
<u>Reason and overview of the Service Bulletin (cause of problem if known)</u>		
<p>All Cavalon aircraft and later Calidus aircraft have a miniature pressure regulator in the pneumatic supply to the pre-rotator clutch (also evidenced by a black pre-rotator interlock push-button on the instrument panel). The clutch is combined with a right-angle gearbox under part number BG3792 (Pneumatic coupling III).</p> <p>During aircraft assembly the pressure re

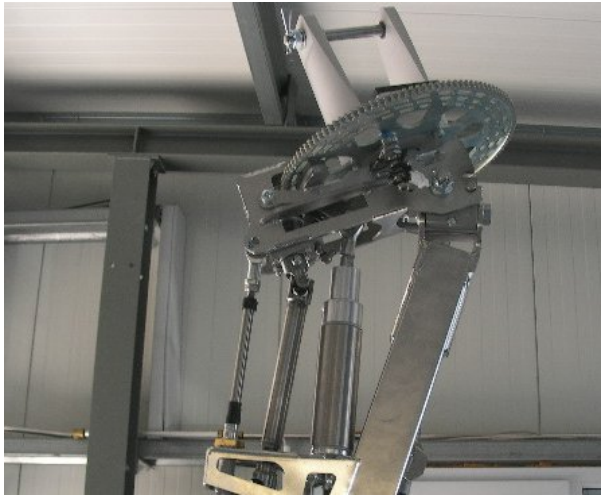
Title: Pre-rotator clutch torque check		
SB No.: 087 Iss2	Related documents MC No: None CCAR No.: None	Compliance Category: OPTIONAL or RECOMMENDED or MANDATORY
Applicability		
Aircraft type & model:	Aircraft serial Nos. affected:	
Cavalon	Any a/c manufactured before 7/14	
Calidus	Any a/c manufactured after RSUK/CALS/021 and before 7/14. Any aircraft retrofitted with Pneumatic Coupling III under MC-212	
<p>alternatively use torque wrench adaptor RSD7233 for a direct reading 40Nm</p> <p>8) When adjustment is complete lock the pressure regulator and mark with torque-seal varnish. Record the pressure setting.</p> <p>9) Remove the special tools, the pressure gauge, T-piece and check-valve.</p> <p>10) Grease the splined shaft with LM grease (RSD4530) and fit to the bendix shaft in the same orientation as it was removed, using a new nyloc nut. Ensure that the bolt-head and nut have adequate clearance for rotation.</p> <p>NB: if MC-260 has been embodied it will not be possible to rotate the shaft unless the pre-rotator clutch is engaged and its brake released.</p>
