# RotorSport UK Ltd

## Service Repair

Repair No.: <b>SR-001</b>	CCAR No.: None	Repair classification: <del>MAJOR</del> or <b>MINOR</b>
Aircraft type: <b>RotorSport UK MT-03</b>	Aircraft serial No affected: . RSUK/MT-03/002 onwards where a Garmin GPSmap is fitted

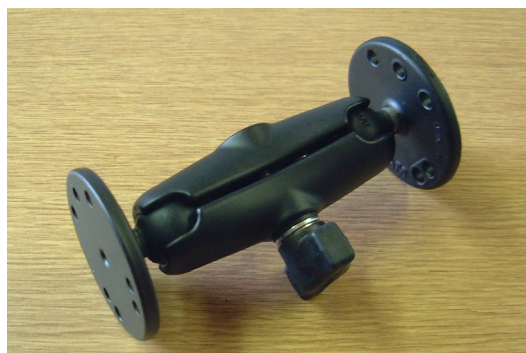
Special tools & Health and Safety requirements, and/or components required for repair:  
Use service kit RSD7112 comprising 1 off RAM extension mounting unit, 4 dome head M4 screws, washers and nylock nuts, and three ties – two 4mm (one spare), one 2mm.

- Quality Inspection requirements after repair:
1. Check that extension unit clamps securely.
  2. Check that the GPS bracket engages correctly with the GPS and locks.
  3. Check that the GPS powers up on aircraft power, and that the power lead is not overstretched.
  4. Check all fastenings disturbed or new-made are tight.
  5. Swing compass and check calibration.
