RotorSport UK Ltd

Service Repair Request and Evaluation/Approval

Repair No.: 005 issue 1, 11/05/10	CCAR No.: None	Repair classification:
Repair No.: 005 1550C 1, 11/05/10	Mod approval No. MC-140	MAJOR or
Aircraft type: MT-03	Aircraft serial No.: OPEN (first application G-YROX)	MINOR

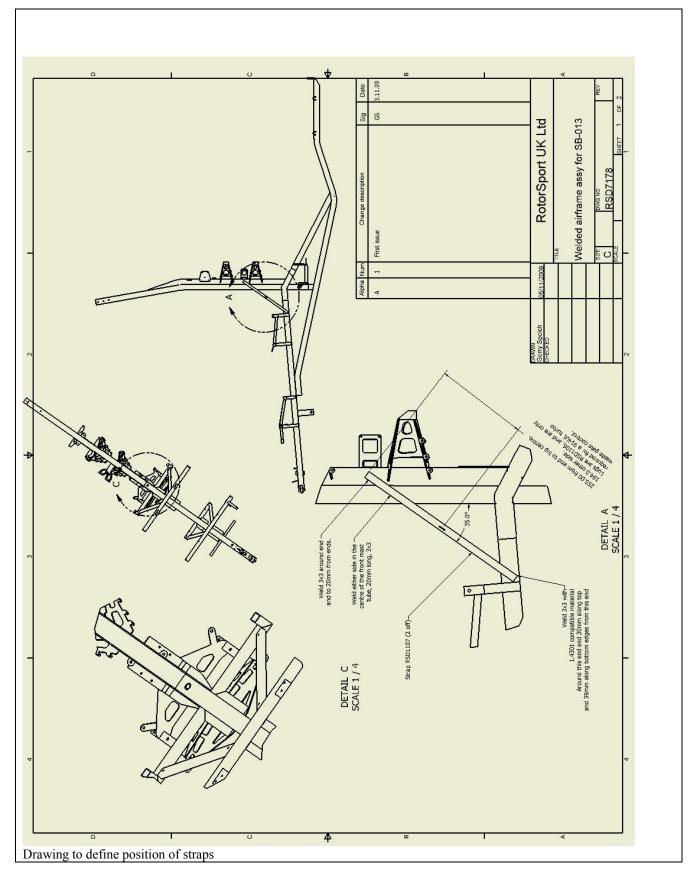
Aircraft has received significant airframe damage during impact into a lake in Thailand whilst circumnavigating the world. The owner wishes to continue the trip with the same frame and aircraft. The frame suffered bent suspension bow brackets and a bent mast. The safest and most robust solution is to cut the mast and suspension mounting area completely out of the airframe, and weld in a new section

- 9. Weld in place two straps, from Fastener and strap kit RSD7175 (straps are 500 x 20 x 3mm 1.4301 stainless steel), carry over from MTOsport and for the MT-03 500Kg. See photos for position, and also fit lugs shown for the 914UL engine TCU. NOTE! Ensure these are in the highest possible position to clear the control forks!
