RotorSport UK Ltd

Service Repair Request and Evaluation/Approval

Repair No.: 016 Iss2, 30.11.18	CCAR No.: CCAR-044 Mod approval No: MC-234	Repair classification: MAJOR or MINOR
Aircraft type: MT-03 and MTOsport (all aftermarket only)	Aircraft serial No. OPEN (first application G-CEHN RSUK/MT03/008

Repair problem description & cause of problem if known:

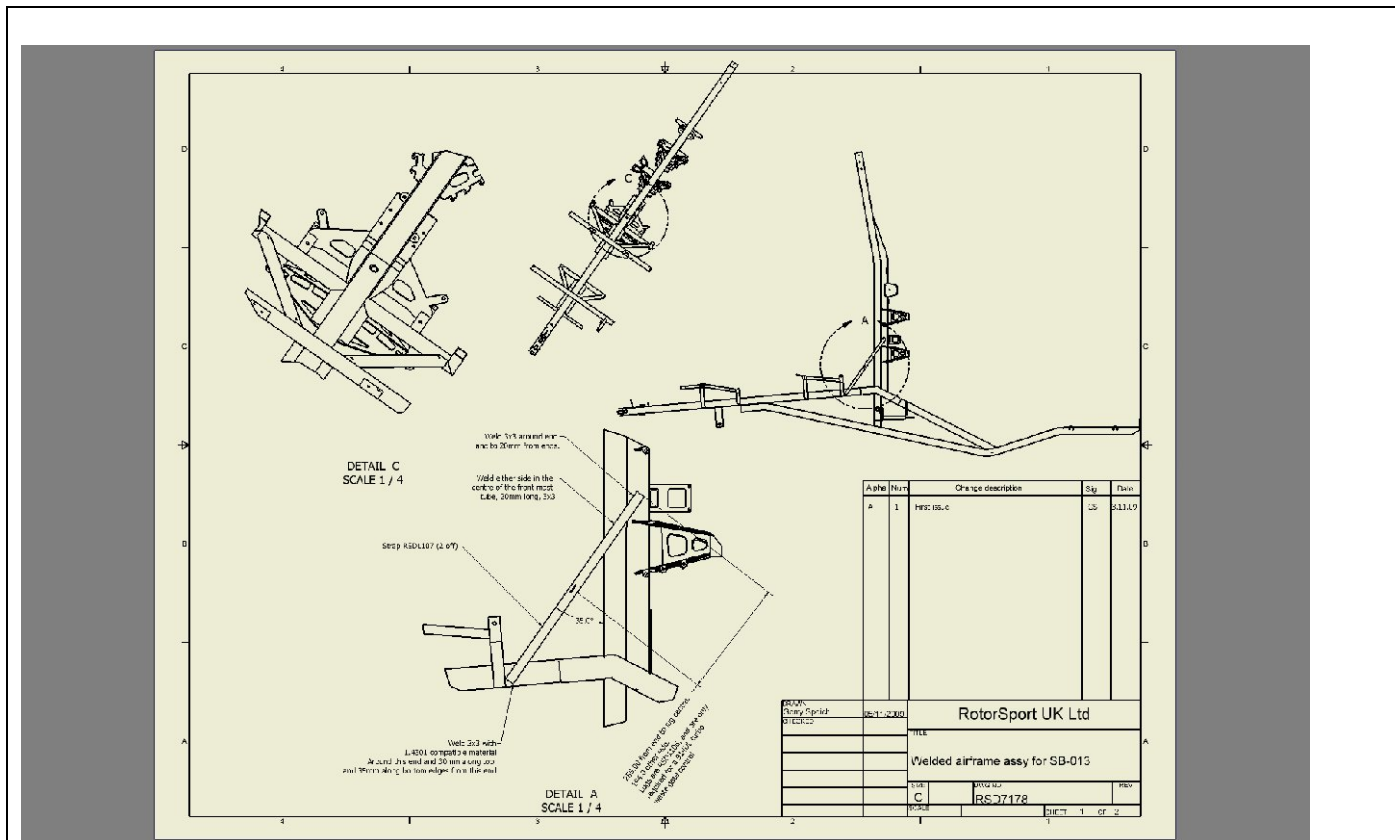
Issue 2 content - alternative lower gusset arrangement when a native MTOS airframe is under repair.

The MTOS airframe (which is approved for 500kg MTOW with the uprated suspension bow) already has the reinforcing straps between the keel tube and main mast section. It is therefore permissible to delete the requirement for items (ii) and (iii) above provided there are no cracks at the base of the mast (i.e. where the upper gusset would be placed). In this case a stronger arrangement of four lower gussets is used, changing the detail of item (i). The gusset set used is RSD1139 "Mast repair alternative lower gusset set". These are triangular pieces cut from a section of 50 x 50 x 2mm stainless-steel box section (same as the mast section, alloy 1.4301) as shown on page 9 and when in place surround the lower mast/keel-tube interface, as can be seen in the photos below. Adjust the length to clear the weld, and shape to suit the area to be welded. The gusset vertical angle should be 30-45deg.
