RotorSport UK Ltd

Service Repair Request and Evaluation/Approval

These are modelled on the previous successful repair of G-CGOT under MC-197/SRA-010

Present Modification Classification the subject of this SRA-017 is MC-246.
Similar previous Modification Classification MC-197/SRA-010.
Auto-Gyro process sheets for Body (complete) C.KU01.01.01
(these are too complex to embed in this document but were made available during preparation for the repair)

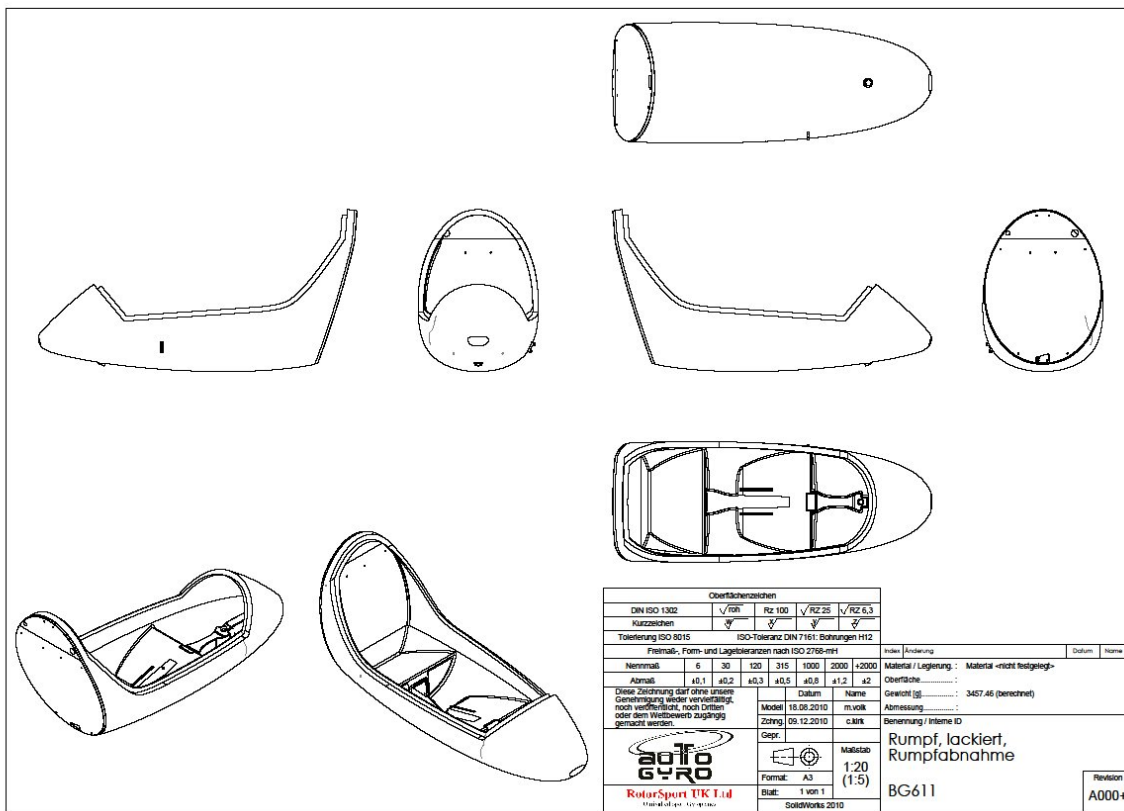
Process sheets for the sub-assemblies show how they are constructed from these listed parts. By examination of these process sheets and review of the bill-of-materials the various layers requiring repair and the constituent materials can be identified.

The various sub-assemblies drawings are shown below:

1. Only Larit L-135 Resin and L-137 hardener may be used for laminating the repair, thoroughly mixed in the ratio 100:35.
2. Locally abrade the outer surface of the enclosure thru to the inner layer so that the body of the enclosure may be built-up with the correct sequence of materials defined in Auto-Gyro process sheet C.KU01.....04 Body.
3. Reinstall the wall of the enclosure using the materials defined. The cut pieces should progressively reduce in size. Use vacuum bag to ensure that the resin fully penetrates the repaired area.

4. Remove the aluminium steering bush to enable the same repair procedure to be applied to the area around the nose-wheel mounting. After reconstruction of the body profile dress the mounting hole and refit the bush, retaining in the composite with beads of resin

6. Cure the repair for 6 hours at room temperature using infra-red lamps to assist.

7. Rub-down and apply polyester gel-coat followed by surfacer-primer to achieve a satisfactory cosmetic finish.
8. Post-cure in a temperature-controlled chamber mounted around the repaired area for 12 hours at 60°C
9. Apply further surfacer-primer and hand-finish to remove blemishes.
10. Rub-down, degrease and re-paint the body using the minimum amount of paint to achieve a satisfactory finish. Air-dry the paint system at room temperature
