# AutoGyro Certification Ltd    Service Bulletin (Permit)

<b>Title: Cavalon Stability and Vibration Reduction upgrade</b>		<b>Release date 05.05.2022</b>
<b>SB-143 Iss1</b>	<b>Related documents</b> Modification: MC-432 engine brace MC-425 teeter tower height change MC-384 mast bushes MC-382 New rotor head with higher pre rotation and Vne CCAR No.: None	<b>Compliance Category:</b>  <b>OPTIONAL</b> <del>or</del> <b>RECOMMENDED</b> <del>or</del> <b>MANDATORY</b>
<b>Applicability</b>		
<b>Aircraft type &amp; model:</b> All UK registered Cavalons	<b>Aircraft serial Nos. affected:</b> All, as applicable	
The maintenance manual to be referenced is this stated or subsequent issue.		RSUK0428 Cavalon USA RSUK0441 Cavalon USA 915iS RSUK0288 Cavalon UK RSUK0426 Cavalon 915iS
<p>This form is the response from AutoGyro Certification Ltd either against a problem found in the product in service requiring a containment or rectification action, or as service information for aircraft modification incorporation. For help, contact RotorSport on 44(0)1588 505060, or email <a href="mailto:compliance@rotorsport.org">compliance@rotorsport.org</a>.</p> <p>The technical content of this document is approved

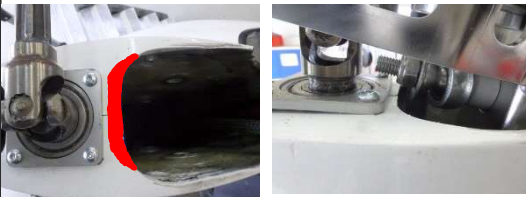
<p>Bearing Retaining Collar</p>
5	It may be necessary to remove material from the composite web between mast rear face/brake-trim cylinder, and pre-rotator drive shaft bearing retaining plate. There must be a minimum of 3mm material visible forward of the forward edge of the drive shaft bearing retaining plate after any re-work.

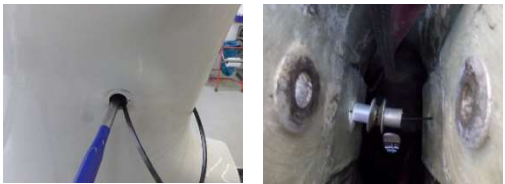
6	If the lower bush in the original mast assembly is the rubber variant it will be necessary to remove the old bushes in the fuselage and insert new from the upgrade set. Insert a cable tie around the fuselage mast and through the bushes. Using a suitable punch, carefully drive out the bushes from outside to inside.

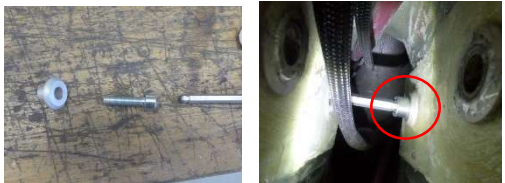
7	Clean and degrease the inside surfaces of the holes and using a suitable tool and bolt, carefully press the 2 new bushes (23901) from the inside into the respective holes left and right of the fuselage mast.

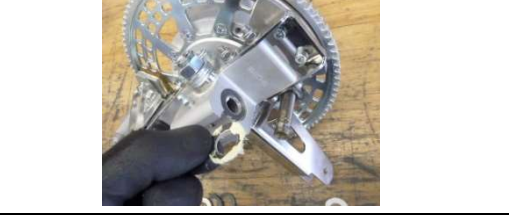
10	Ensure that the 2 cone washers and thrust washer (with flat section lowermost) are assembled in both forward and rear roll axis of the gimbal with Lagermeister WHS2002 (30477) or equivalent. Assemble the rotor head onto the mast using AMM job cards 62-20-00 8-1, 62-31-00 6-1, 62-32-00 5-1 & 62-51-00 4-1 as reference.

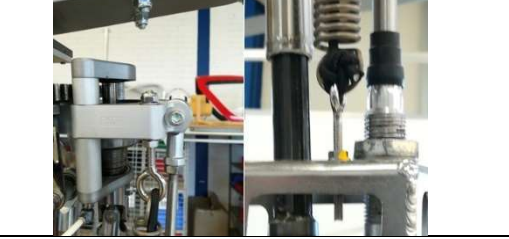
12	Assemble the trim spring as shown. It should be assembled so that there is light tension in the spring and rubber when the head is fully to the rear.

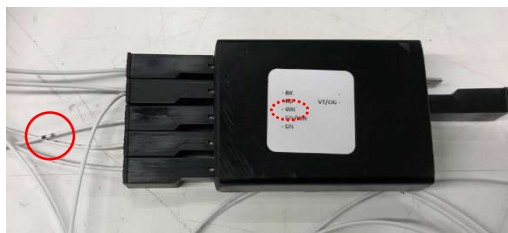
17	Connect the cables from set 46141 to the control unit using cable markings and control unit label as reference.

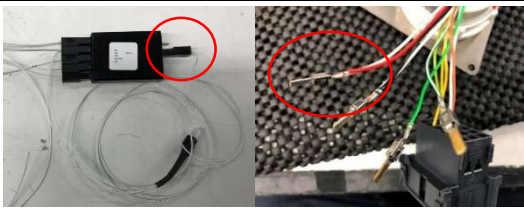
18	Crimp a positive lock contact to cable VT/OG from the LED and connect to the control unit. Crimp the RD/BR cable to the red cable of the grey 18 pin plug.

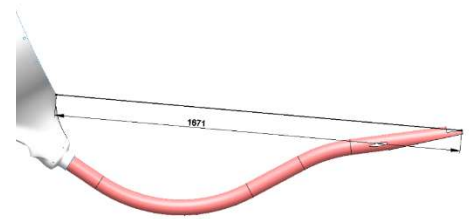
Keel tube I – short (1671mm)

- 1 If the Cavalon is fitted with keel tube I (short version) it **MUST** be upgraded to keel tube II when upgrading from rotor head II to rotor head III.

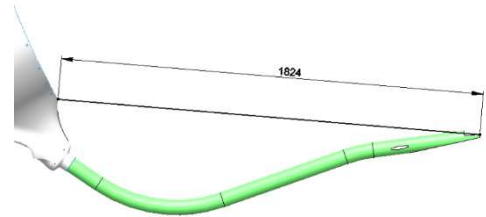
Keel tube II – long (1824mm)

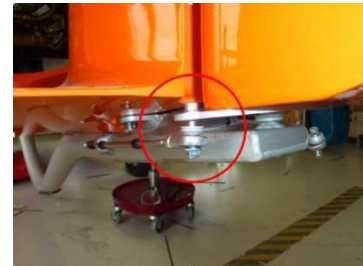
- 2 Remove the left and right rudder control cable to rudder bolts  
Note the position of washers and spacer when removing.

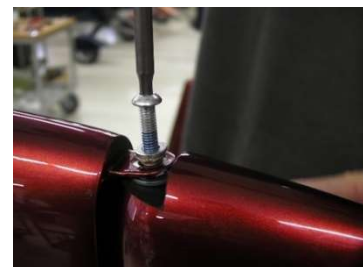
- 3 Supporting the rudder, remove the upper bolt, bush and washers.  
Note the position of items for re-fitment.  
Tilt the upper rudder slightly rearwards to clear the attachment bracket of the stabilizer, and slide upwards off of the lower bearing pin.

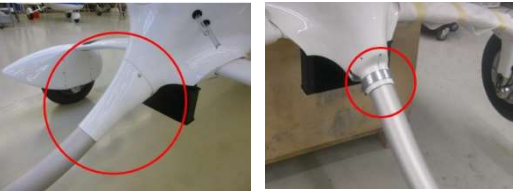
11	Remove the keel tube clamp cover and slide rearwards along the keel tube. Loosen the keel tube clamp and slide rearwards along the keel tube.

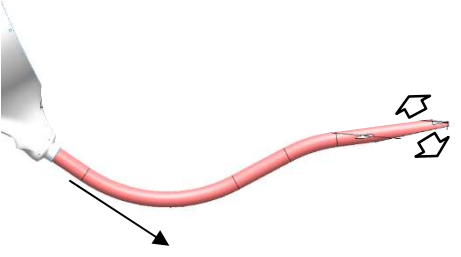
14	Using the keel tube end as a lever, rotate the keel tube left and right to break any potential seal of the Paste 20 filler. Pulling rearwards and downwards, remove the keel tube from the fuselage.

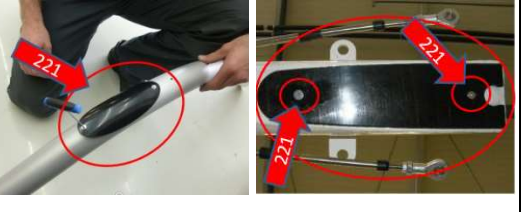
<b>Assembly of new keel tube</b>		
15	Assemble the center and rear skid plates on the replacement keel tube using Loctite 221 on the screws.

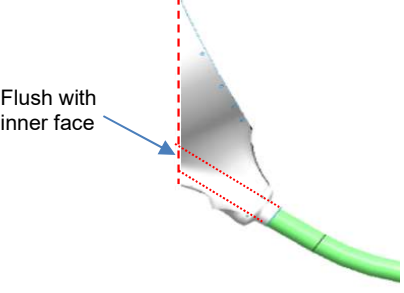
17	Feed the keel tube through the composite of the clamp. Apply a thin film of locally procured Paste 20 or equivalent (eg. Six10 Thickened Epoxy Adhesive) to the relevant areas of the keel tube at the bulkhead tube and clamp shoulder before inserting into the composite. Gently push the tube into position into the engine bulkhead composite tube. The end of the keel tube should be flush with the forward face of the engine bulkhead. <b>Note: It is important that the next step be carried out IMMEDIATELY, before the epoxy sets.</b>

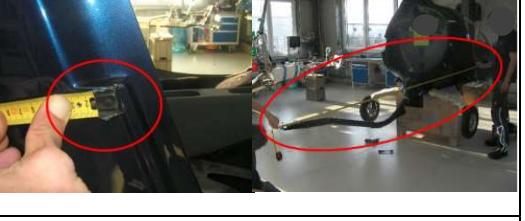
18	Place the keel tube clamp in position and tighten lightly to allow some movement in the keel tube. Centralize the keel tube by taking measurements from the lower corner of the cabin door hand recess to rudder pin. Align the keel tube so that the distance between rudder pin and lower corner of the cabin door hand recess is equal on both sides and tighten the clamp to 10Nm. Allow the epoxy to harden overnight (minimum 12 hrs).

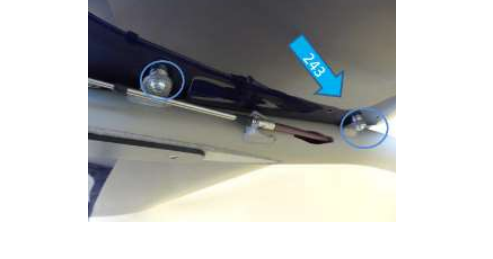
27	<p>Assemble the tail plane to the keel tube using the same combination of spacers and washers that were previously removed from each mounting point using Loctite blue 243 (10Nm). Ensuring the flooring is horizontal, measure from each trailing edge corner to the ground. The difference should not be greater than 10mm. Add washers to both mountings on the one side to adjust as required.</p>

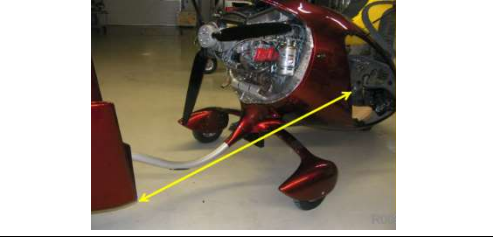
28	<p>Check alignment of the tail plane to fuselage. Measure the distance from the lower corner of the cabin door hand recess to the outer forward corner of the tail plane. The distance of the starboard measurement should be 20mm +/-5mm <i>shorter</i> than the port. If this is not the case, loosen the mounting bolts, adjust and re-tighten.</p>

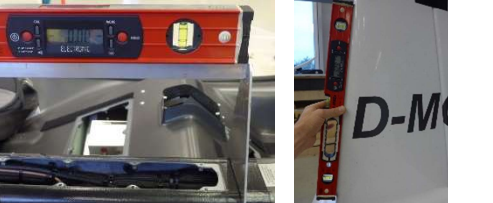
29	<p>Check the tail plane angle. Place a suitable digital spirit with level mounting plate tool (48006) on the center console and set to zero. Place the spirit level on the leading edge of the vertical fin of the tail plane and measure the angle. The angle should be 82.0° +/- 1.0°.</p>

<i>Tail plane angle check</i>		
30	<p>If the keel tube is not to be replaced, carry out a tail plane angle check.</p> <p>Refer to module “<i>Keel Tube I to II Upgrade</i>” serial 29.</p> <p>If it is not possible to attain the correct tail plane angle with the maximum amount of spacers, it is strongly recommended that the keel tube be replaced with the newest version.</p> <p><b>If this is not undertaken it may result in poor flight characteristics of the aircraft.</b></p>	
<i>Functional checks</i>		
31	Carry out a ground run for functional and proof checks of the pre-rotator system and indication.	
<i>Final steps</i>		
32	<p>Replace teeter block II with teeter block III on the rotor system using AMM job card 62-11-00 6-3 as reference.</p>

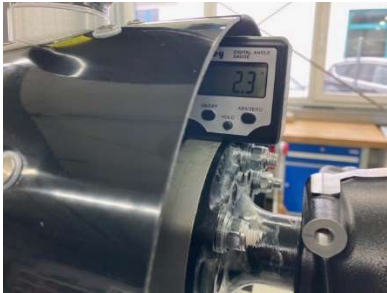
<div style="border: 1px solid red; padding: 5px; color: red; width: fit-content; margin-left: 10px;">       Re-assemble with 1 x 9mm spacer only     </div>
7	<b>FOR THE CAVALON 915iS VARIANT ONLY:</b> Check the engine thrust angle. Using 0° at the center console as the reference point, place a suitable digital spirit level on the top of the propeller gearbox spacer or propeller flange face and measure the thrust angle. The angle should be 0° (max 0.5° nose down, 1.0° nose up). If this cannot be achieved then AutoGyro ( <a href="mailto:airworthiness@auto-gyro.com">airworthiness@auto-gyro.com</a> ) should be contacted.

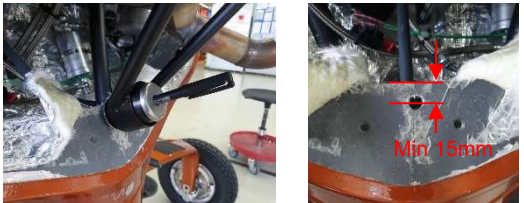
7	Rotate the support arm into position and mark the position of the hole onto the fuselage. There must be a minimum of 15mm material from the center of the hole to the upper edge of the composite. If this is not the case, use U10/30 washers to shim the support arm rearwards to achieve this. Drill a 10.5mm hole in the marked position.

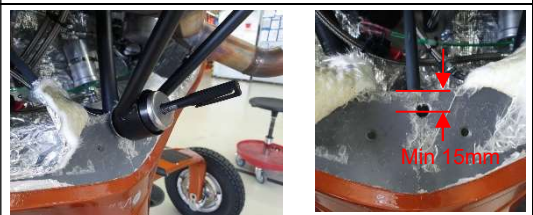
14	Rotate the support arm into position and mark the position of the hole onto the fuselage. There must be a minimum of 15mm material from the center of the hole to the upper edge of the composite. If this is not the case, use U10/30 washers to shim the support arm rearwards to achieve this. Drill a 10.5mm hole in the marked position.

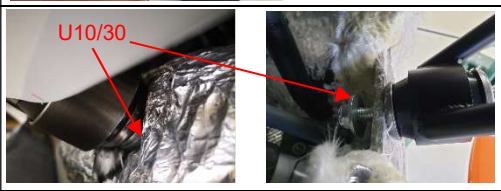
15	Loosely assemble the support arm to the fuselage with any U10/30 packing washers required as previously noted in the step above.

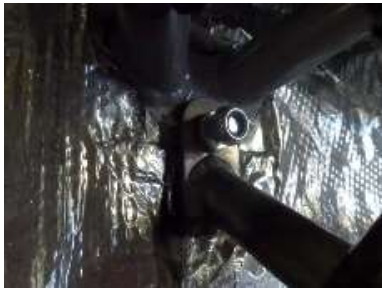
20	Position the new adjustable keel tube reinforcement arm (48163) on to the M6x35 bolt and tighten.

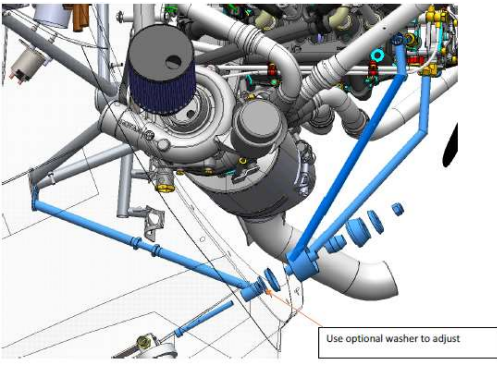
21	<p>Adjust the length of the arm at the center threaded joint so that the lower attachment stub aligns with the assembly hole.</p> <p>The face of the attachment stub must be parallel to the rear face of the fuselage composite.</p> <p>If there is a gap between assembly stub and composite when the faces are parallel, shim with U10/30 washer if required.</p> <p>Insert the bolt through both arm assemblies from inside the engine compartment as shown and secure with the M10 Nyloc nut.</p>

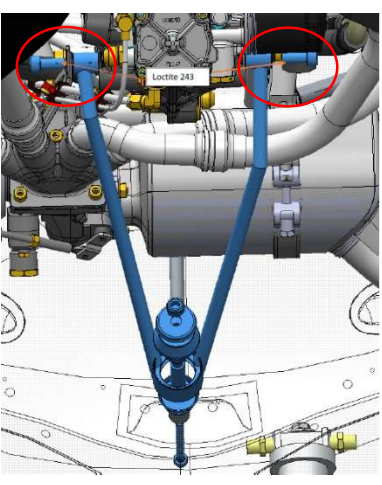
22	Remove the support arm upper attachment bolts one at a time, apply Loctite blue 243 and re-assemble then tighten.
