RotorSport UK Ltd Service Bulletin (Permit)

Title: Control cable clamps		
SB-102 Iss1	Related documents Modification: MC-329 CCAR No.: None	Compliance Category: OPTIONAL or RECOMMENDED or MANDATORY
Applicability		
Aircraft type & model: Cavalon	Aircraft serial Nos. affected: RSUK/CVLN/any	
The maintenance manual to be referenced is this stated or subsequent issue.		RSUK0288 Iss4
This form is the response from RotorSport UK Ltd either against a problem found in the product in service requiring a containment or rectification action, or as service information for aircraft modification incorporation. For help, contact RotorSport on 44(0)1588 505060, or email compliance@rotorsport.org . The technical content of this document is approved under the authority of the UK CAA Design Organisation Approval Ref: DAI/9917/06

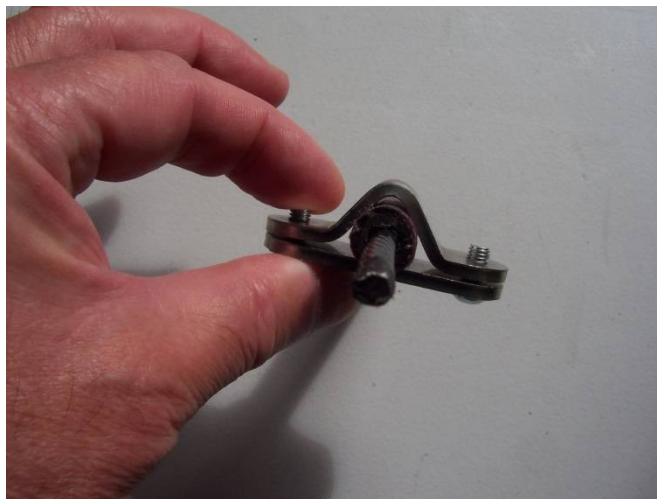
Fig 2 Control cable clamp

Under certain circumstances operating clearances in the push-pull control cables (for pitch and roll control) can allow the transmission of rotor vibration to the control stick. Fitment of these clamps enables the clearance to be adjusted and the vibration reduced (See Fig 2).

3. Apply Loctite 243 to the screw threads and fit one clamp to each control cable. Position so that the clamp is at the lowest point of the curve, clear of contact with the body (Fig 2).

4. Ensure clamps are fitted, and any cut cable ties replaced, such that the clamp components cannot rub or fret to the aircraft or other cables in the centre channel.

5. Tighten the screws equally to 1Nm.
6. By moving the control stick, establish that the free play in the cable has been reduced to a minimum consistent with free movement. Adjust the clamp screws as required
