RotorSport UK Ltd Service Bulletin (Permit)

Title: Replacement expansion tank MTOS		
SB-110 Iss1	Related documents Modification: MC-348 CCAR No.: None	Compliance Category: OPTIONAL or RECOMMENDED or MANDATORY
Applicability		
Aircraft type & model: MTOsport	Aircraft serial Nos. affected: RSUK/MTOS/057 RSUK/MTOS/059 RSUK/MTOS/060 RSUK/MTOS/061	
The maintenance manual to be referenced is this stated or subsequent issue.		RSUK0044 Iss: 6
<p>This form is the response from RotorSport UK Ltd either against a problem found in the product in service requiring a containment or rectification action, or as service information for aircraft modification incorporation. For help, contact RotorSport on 44(0)1588 505060, or email compliance@rotorsport.org.</p> <p>The technical content of this document is approved under the authority of the UK CAA Design Organisation Approval Ref: DAI/9917/06</p>

AG-SB-2016-01-B-EN – Replacement Expansion Tank MTOsport

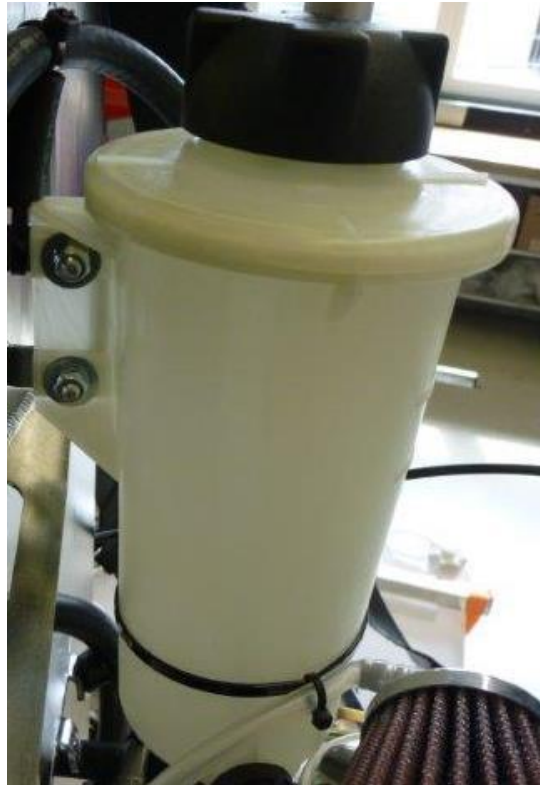
Fig.3: Composite expansion tank II

In few cases fatigues in composite expansion tanks occurred by high thermal load. These fatigues may result in loss of engine coolant.

MTOsports, which are retrofitted with the water tank II (see figure 3 in chapter **Compliance Procedure**).

- 9 Remove the hose coming from the expansion tank to the water distribution pipe.
- 10 Unscrew and remove the nuts and washers of expansion tank (Fig.3).
- 11 Unscrew and remove the screws and expansion tank (Fig.3).

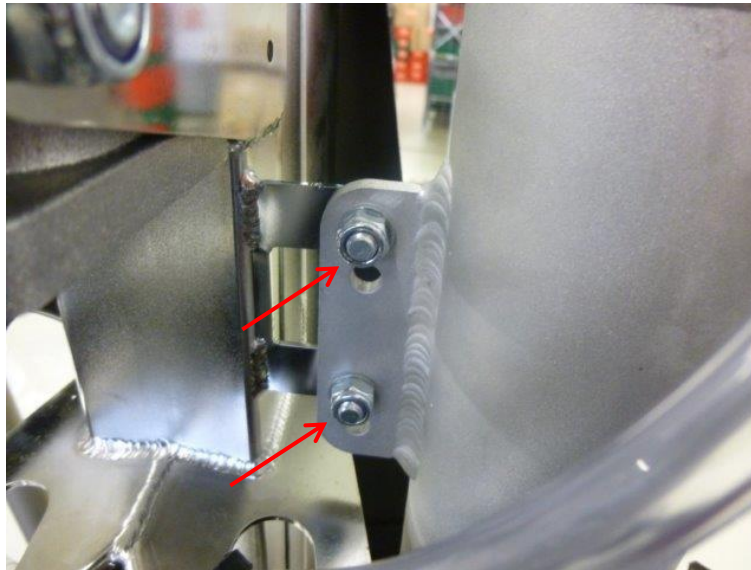
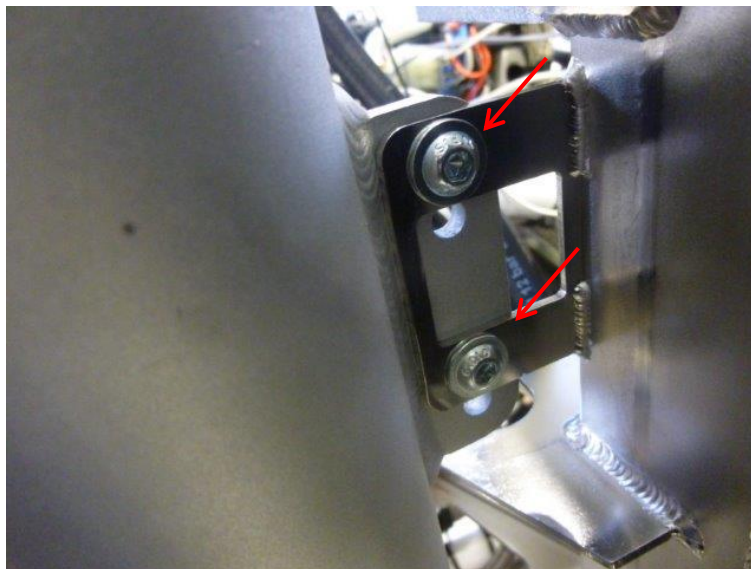
Fig.5: Installed expansion tank III

Fig.6: Installed expansion tank III

- 12 Install the nipple with the copper washer and the crimp to the new expansion tank. Avoid any abrasions (Fig 4).
- 13 Install the new expansion tank with new screws, washers and nuts (Fig. 5 and 6).

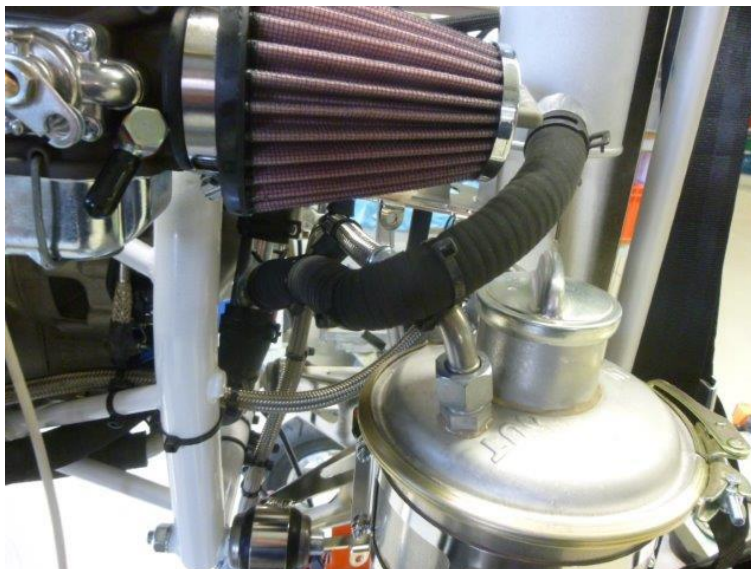
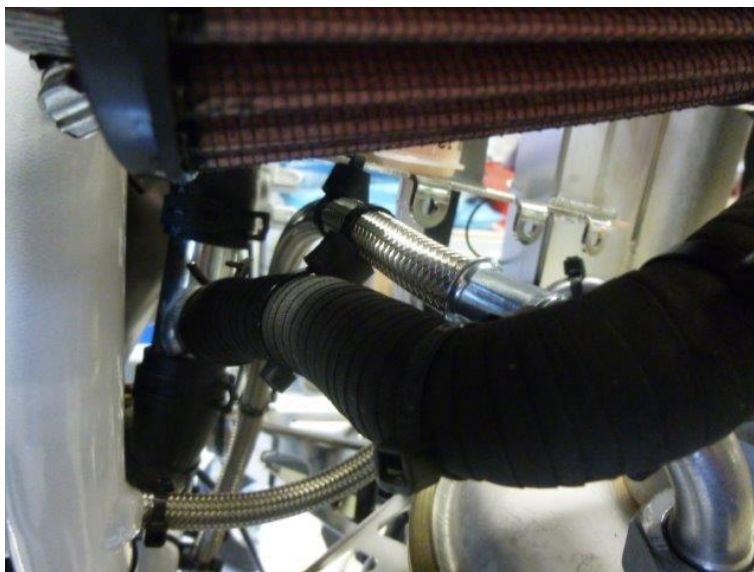
Fig.8: Connection between expansion tank and water distribution pipe with one radiator at the rear of the engine

Fig.9: Connection between expansion tank and water distribution pipe with one radiator at the rear of the engine

- 15 Connect the 90 degree bow coming from the expansion tank to the water distribution pipe. Fix the hose with crimp. Avoid any abrasions. Use cable ties and spacers (Fig. 8, 9 and 10).
